TORRINGTON®

Roller Bearing Service Damage and Causes

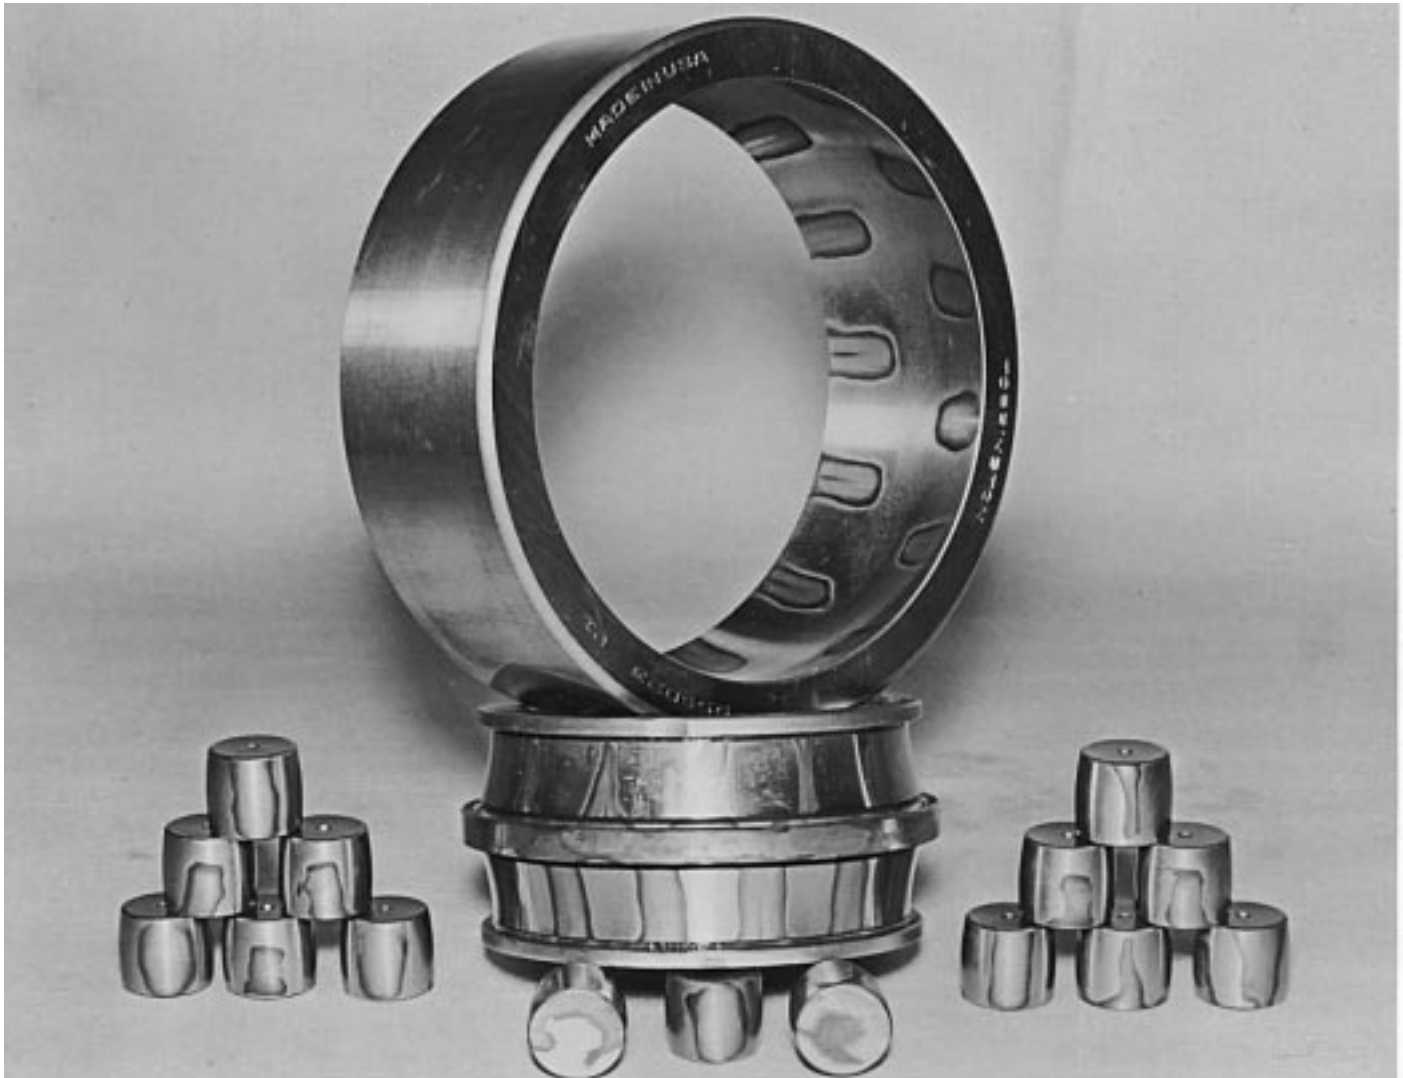
STAINING IN STORAGE

Improper storage conditions often result in damage to bearings. Figure 1 shows staining that occurred on a bearing stored with inadequate protection in a humid atmosphere. Special types of packaging are available for storage of bearings in high humidity atmosphere.

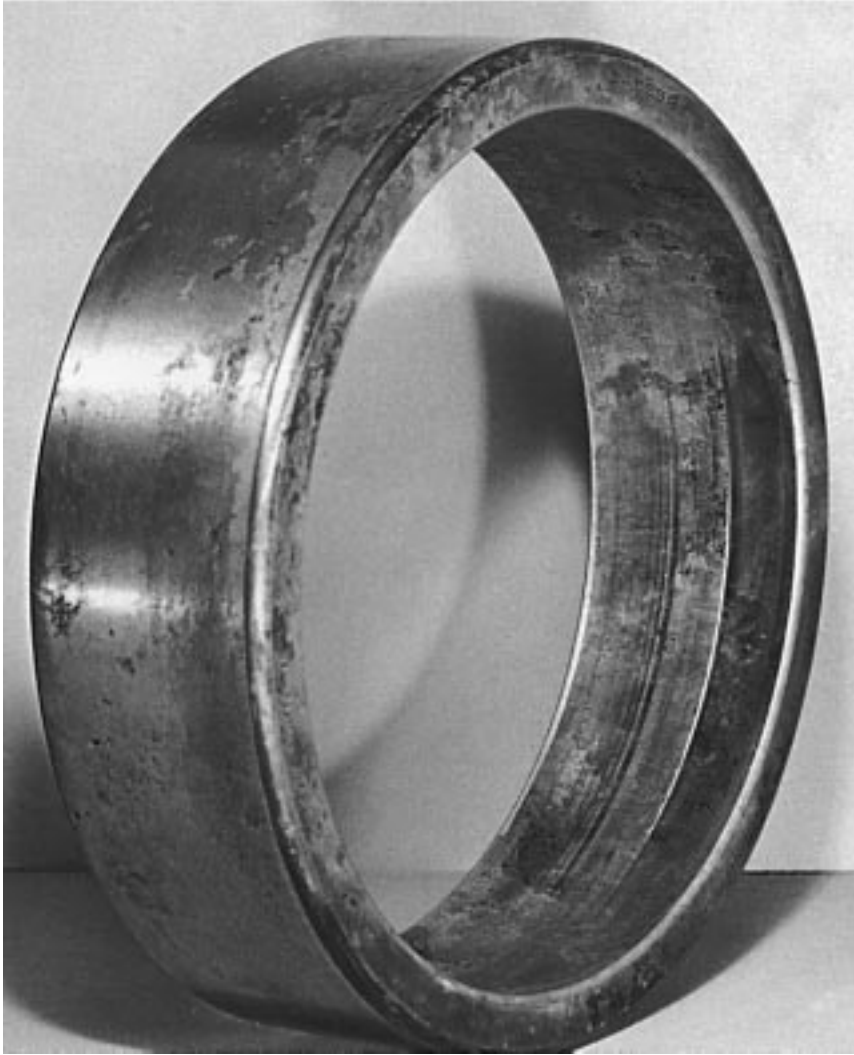
Figure 2

CORROSION

This outer ring was a component of a bearing operation in a high humidity atmosphere. Corrosion is general. See Figure 3.

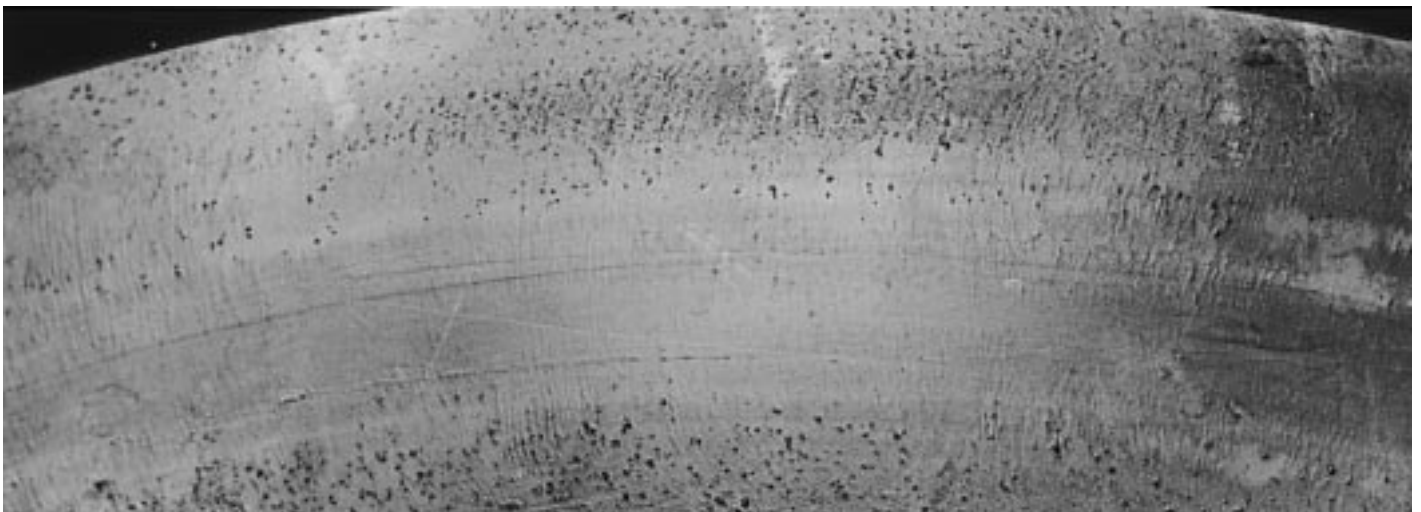
Figure 3

CORROSION

An enlargement of Figure 2 shows the innumerable pits in the surface. Each can be a nucleus for complete failure.

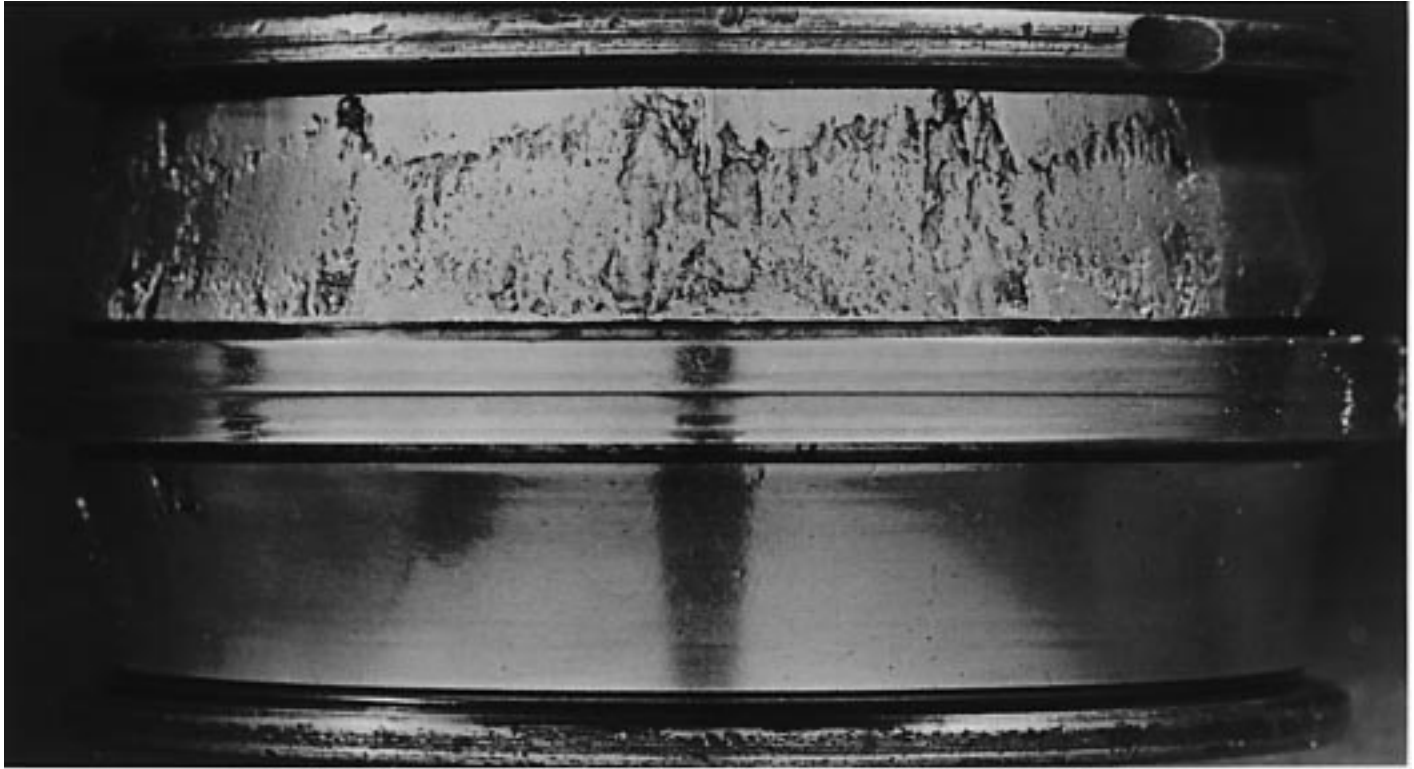
Figure 4

CORROSION AND FAILURE

Spalling frequently occurs from corrosion. This photograph shows an

inner ring where failure has occurred at roller spaced intervals and had its inception in corroded areas. See Figure 5.

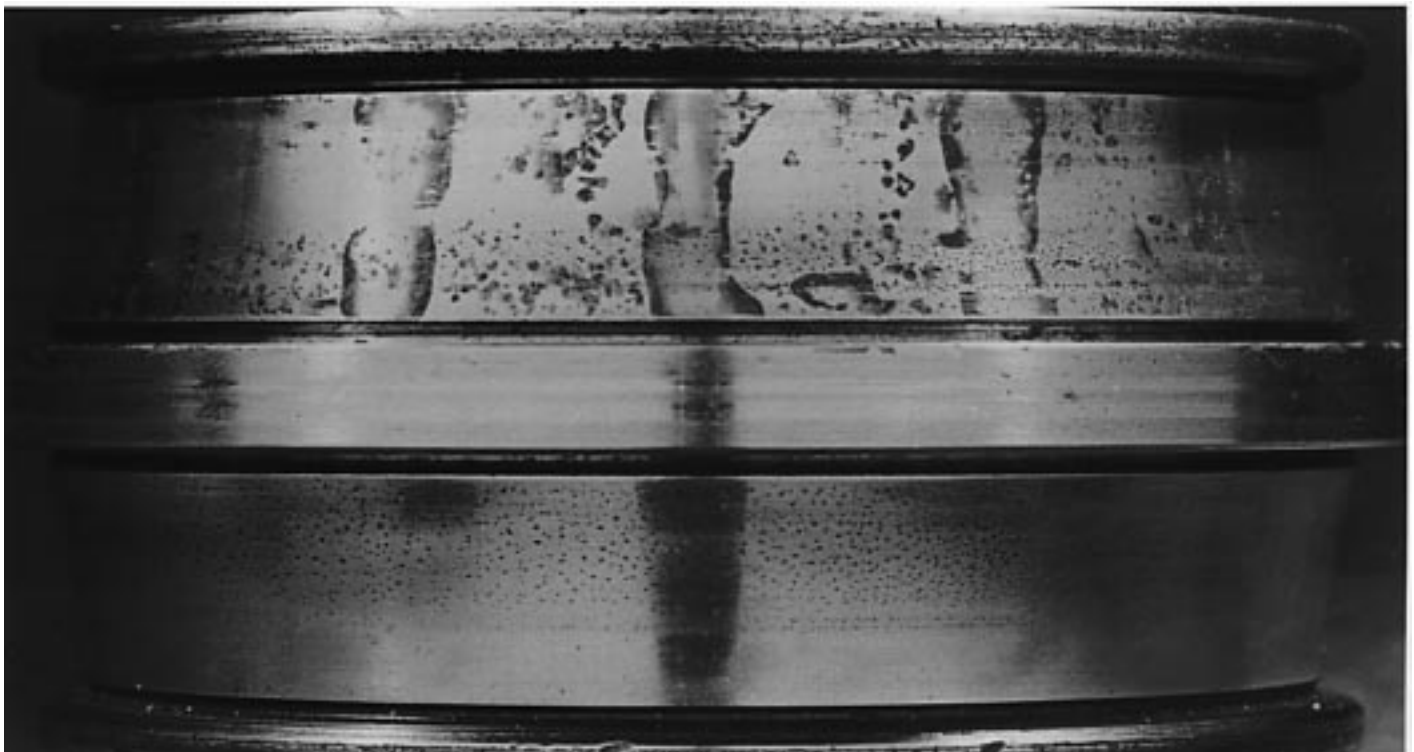
Figure 5

CORROSION AND FAILURE

The opposite side of the same race shown in Figure 4 is illustrated. The original corrosion pattern which resulted in the failure is apparent.

The corrosion was due to entrapped moisture while the bearing was stationary.

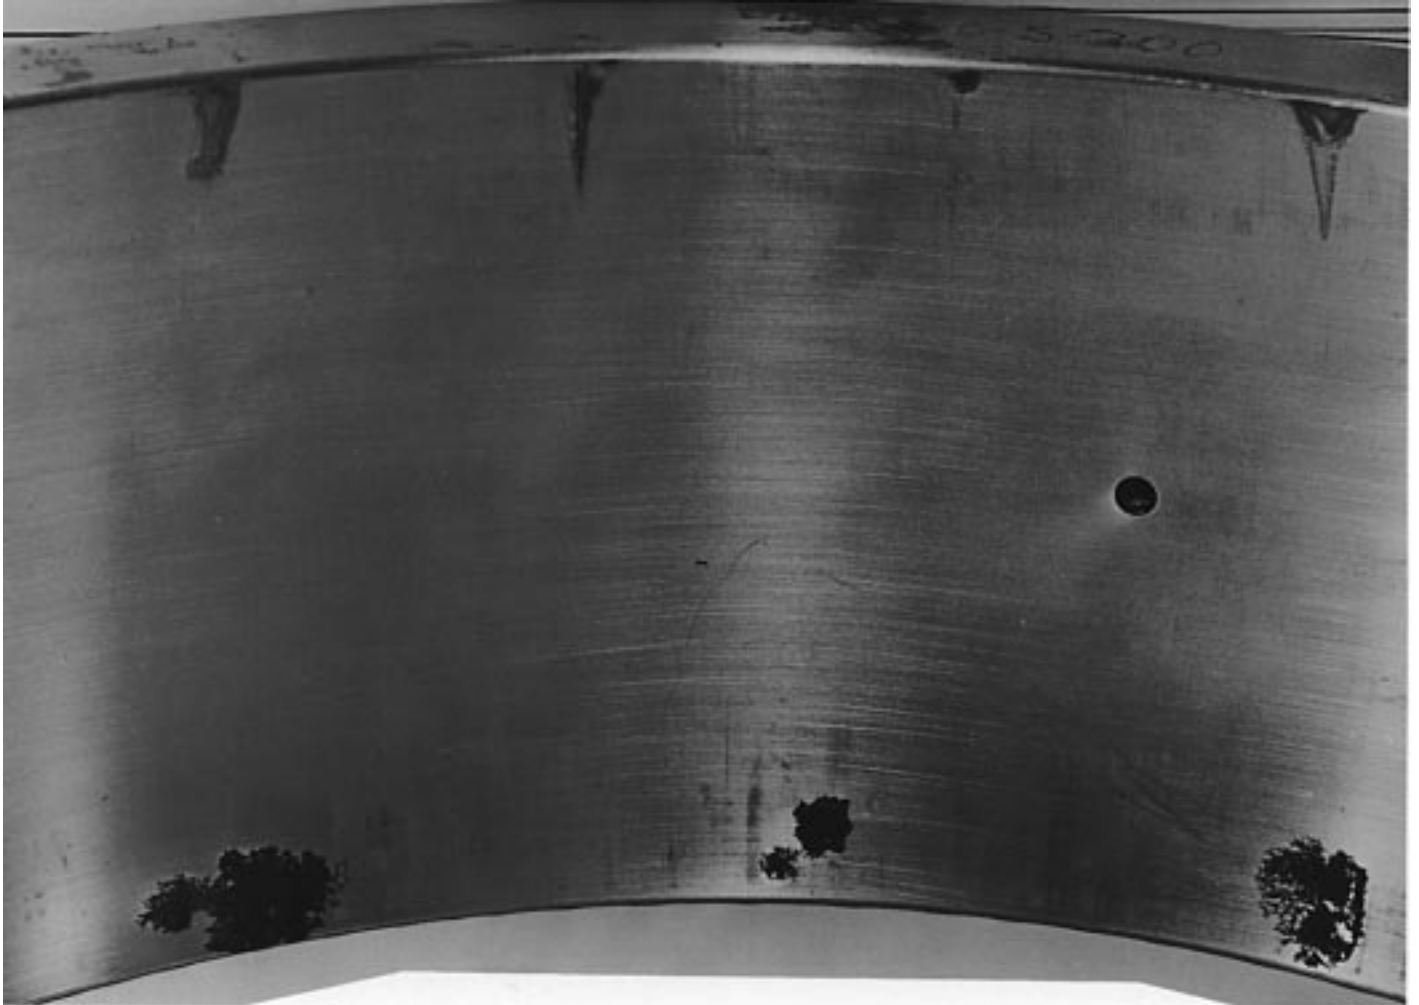
Figure 6

CORROSION IN STORAGE

This is another example of the corrosion which results from storing bearings in a moist atmosphere. The corrosion takes place underneath the rollers where moisture is trapped.

If this bearing had been put in service, it probably would have failed in a manner similar to that shown in Figure 4.

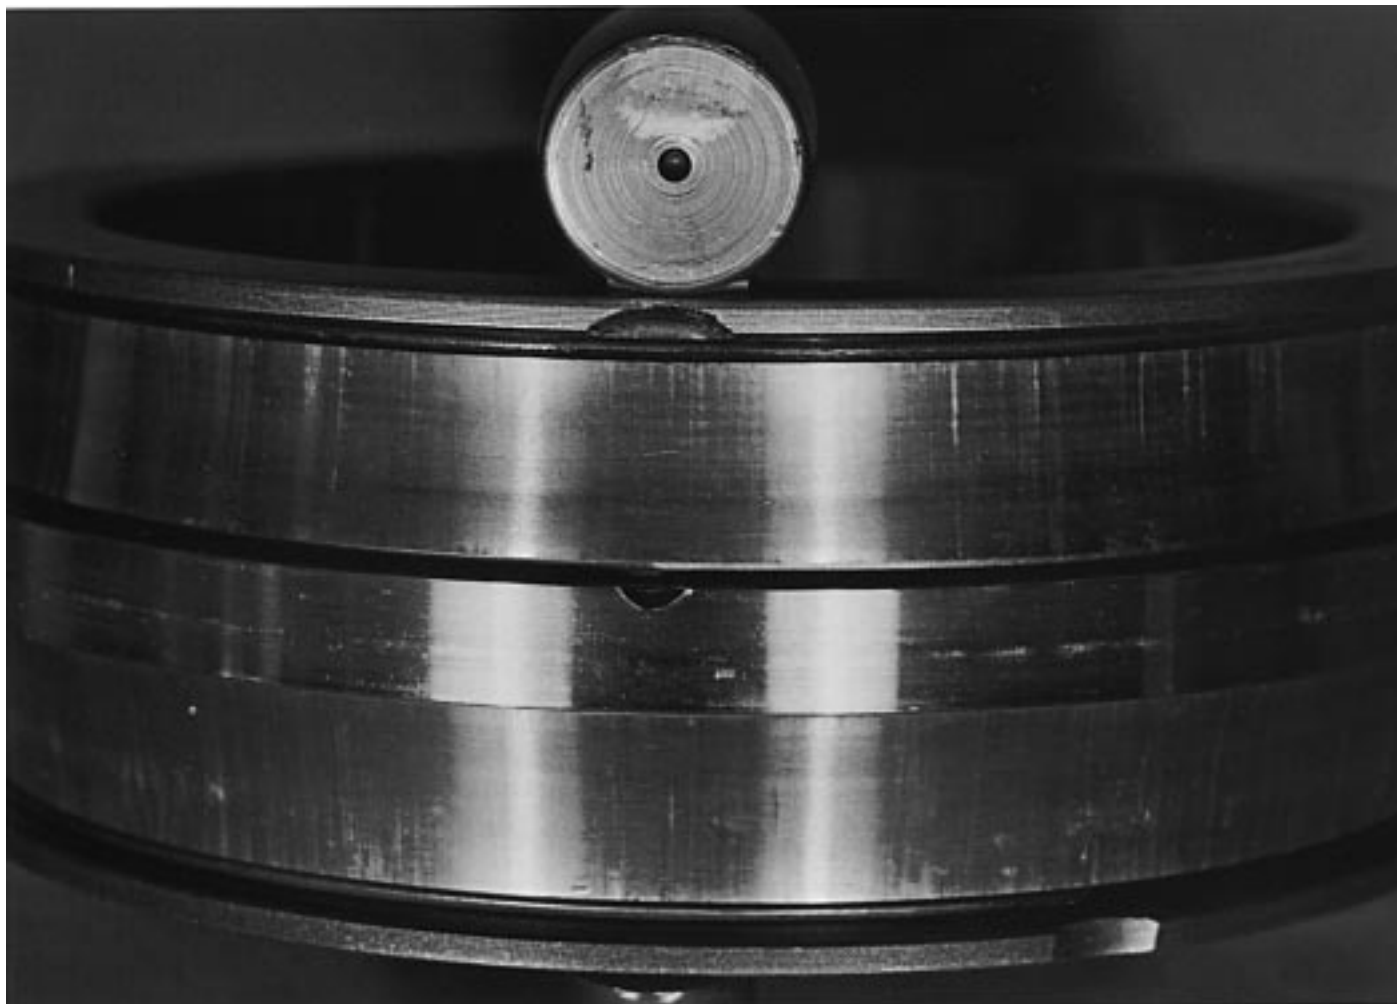
Figure 7

INSTALLATION DAMAGE

Bearings are frequently damaged when improperly handled, particularly during installation. Here are the inner ring and a roller of a bearing forcibly realigned after a roller had been radially displaced. Both flanges are broken and the roller is marked. Refer to Figure 8.

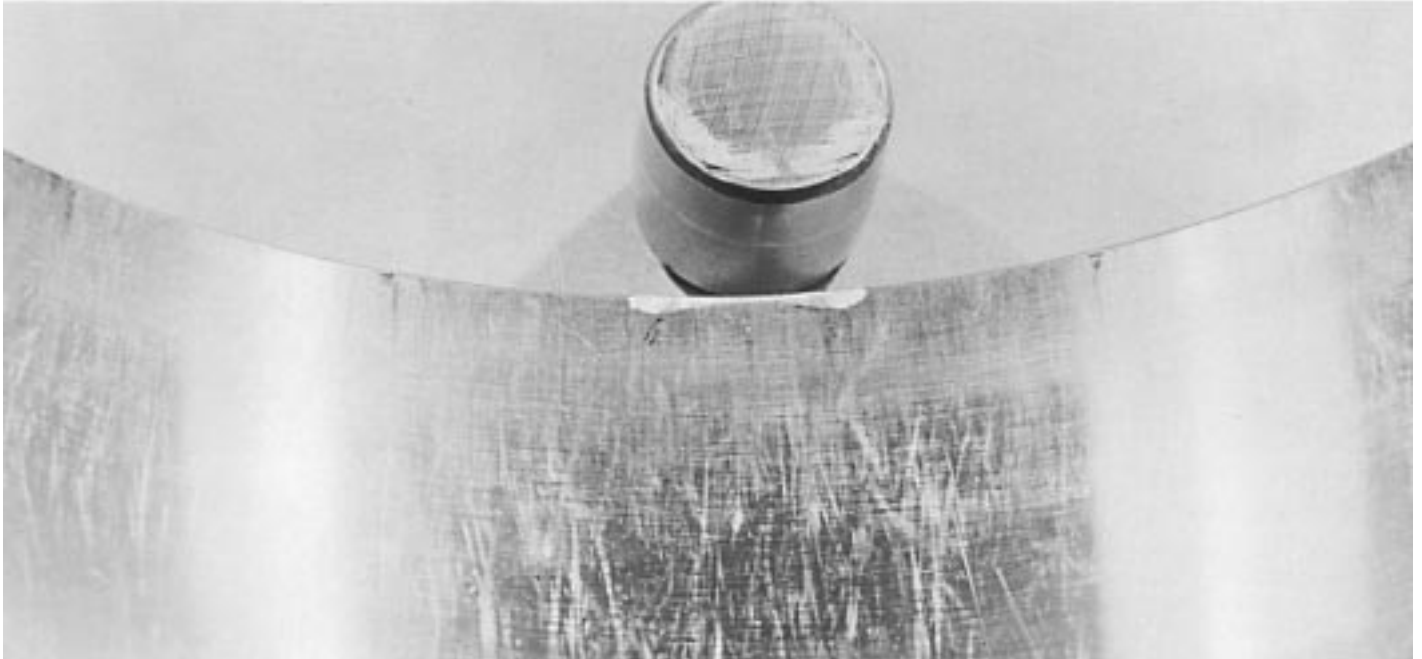
Figure 8
INSTALLATION DAMAGE

This is the companion outer ring (and a roller) of the inner ring of Figure 7. Severe mishandling is necessary to cause this damage.

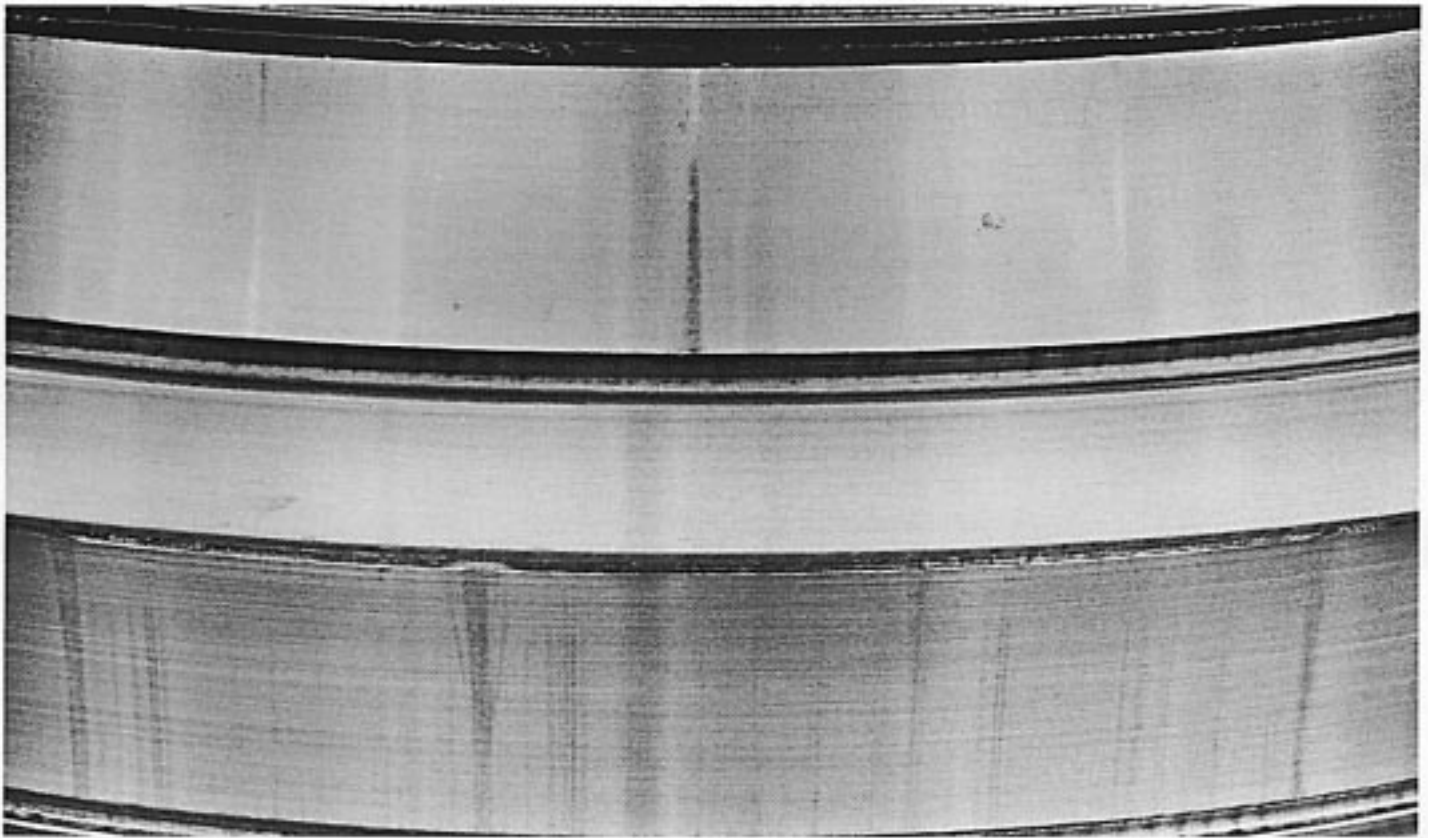
Figure 9
BRINELLED RACEWAY

Brinelling of the raceway illustrated was caused by roller impact. The damage occurred during mounting of the bearing. There is a displacement rather than a loss of metal in brinelling. Raceway

surface brinelling results in a noisy bearing and such a mark can be the nucleus for premature failure.

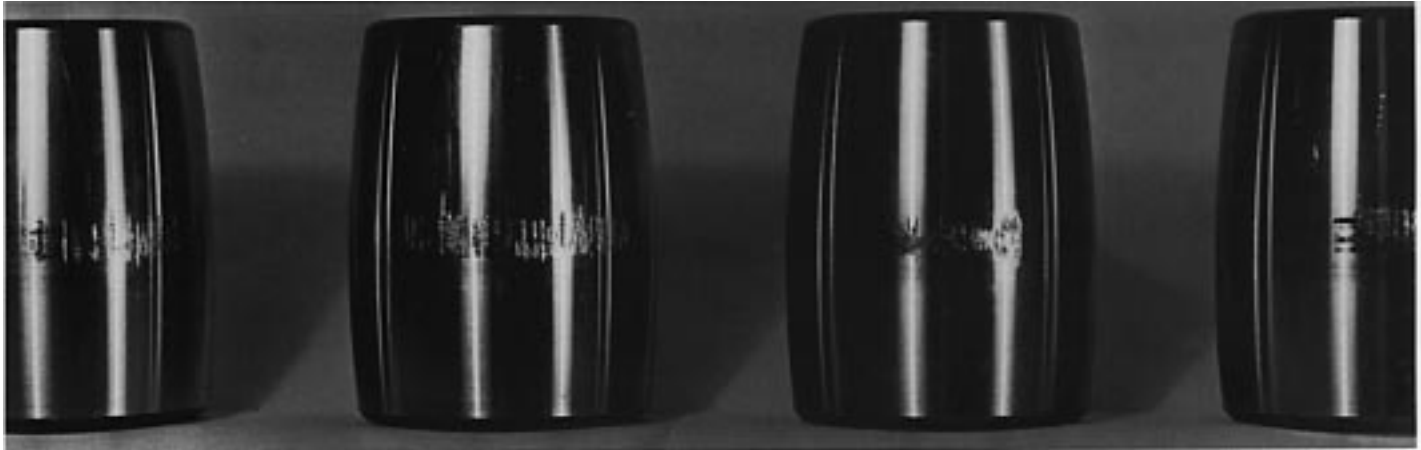
Figure 10

DAMAGE IN TRANSIT

Vibration during shipping can be detrimental to a bearing and for that reason a new bearing is always wrapped and placed in a container in such a manner as to offer the maximum protection against such occurrence. This photograph shows scuffed rollers from a bearing which was installed on a piece of equipment and shipped without any provisions made to protect the bearing. The vibration in transit caused the scuffing. A bearing in this condition is noisy in operation and early failure can be expected. Figure 12 is of the companion outer ring.

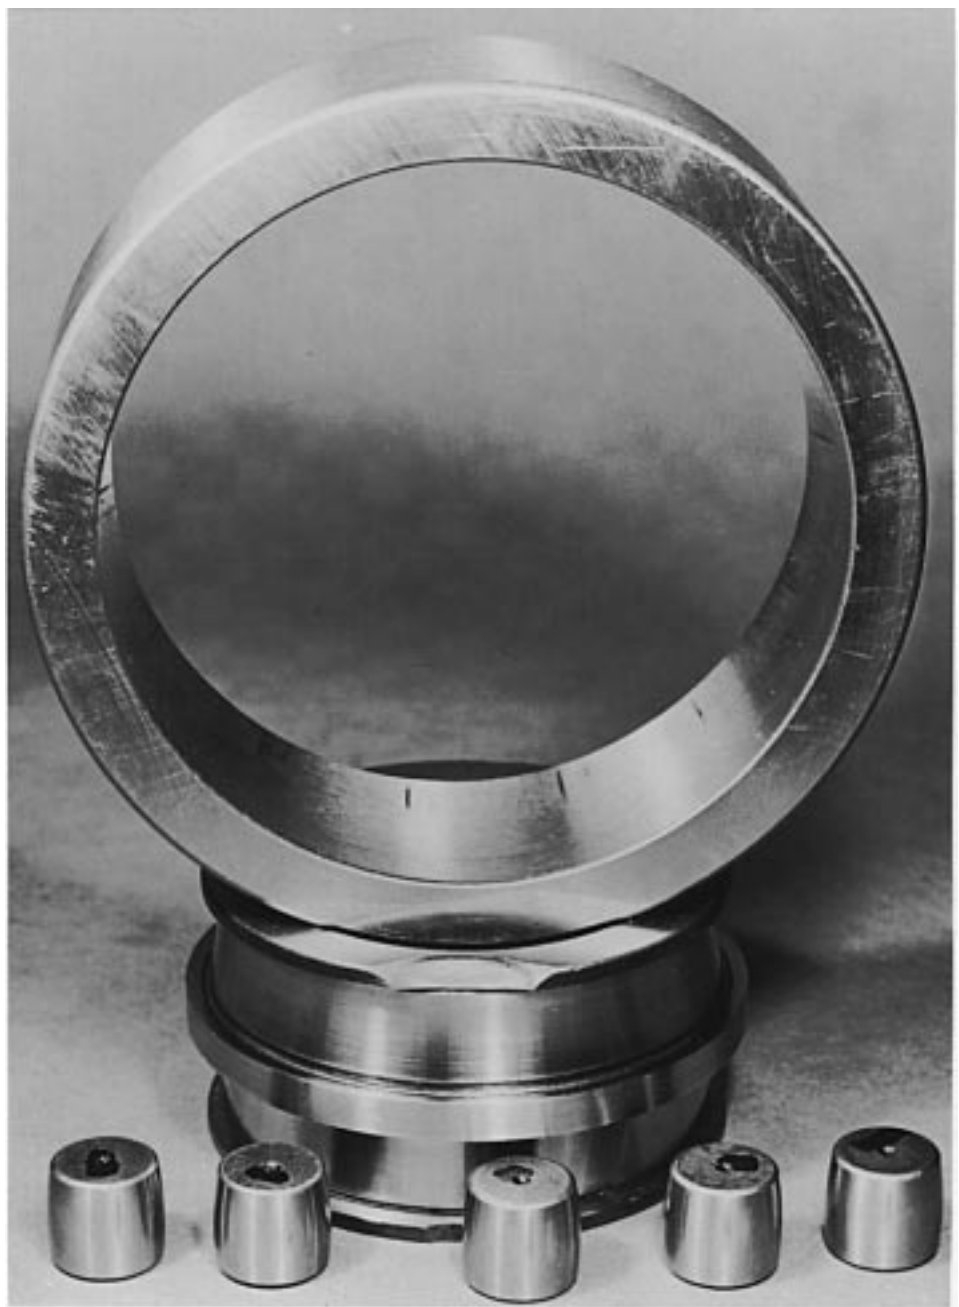
Figure 11

INSTALLATION DAMAGE

This photograph shows a bearing on which the face of an inner ring was chipped by a blow during installation. (See Torrington Catalogs for proper procedure for mounting bearings.)

It should be noted that the outer raceway and rollers were scuffed by the same impact.

Such scuffs are nuclei for failure.

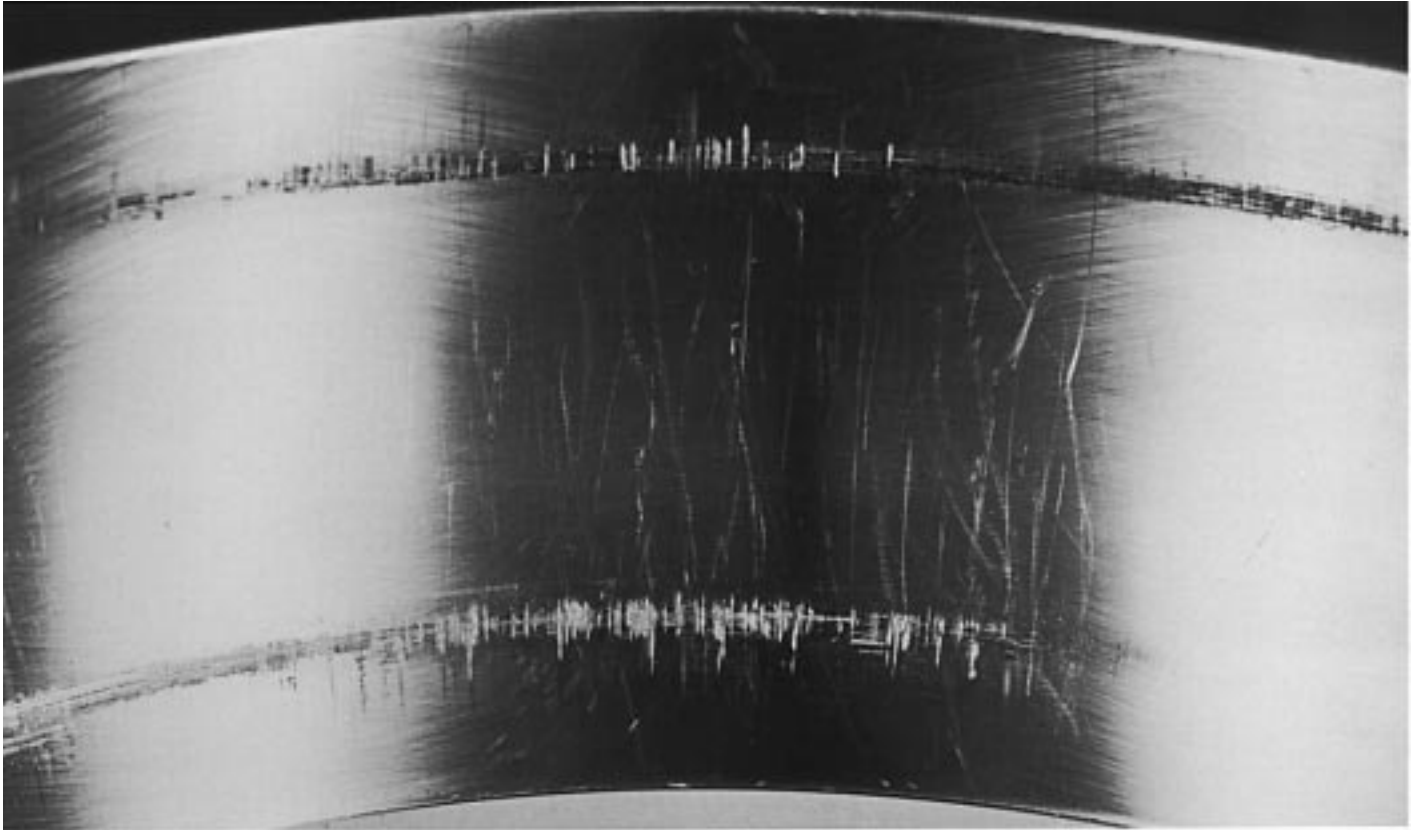
Figure 12

DAMAGE IN TRANSIT

See Figure 10. Shown in this photograph is the damaged raceway surface of the outer ring.

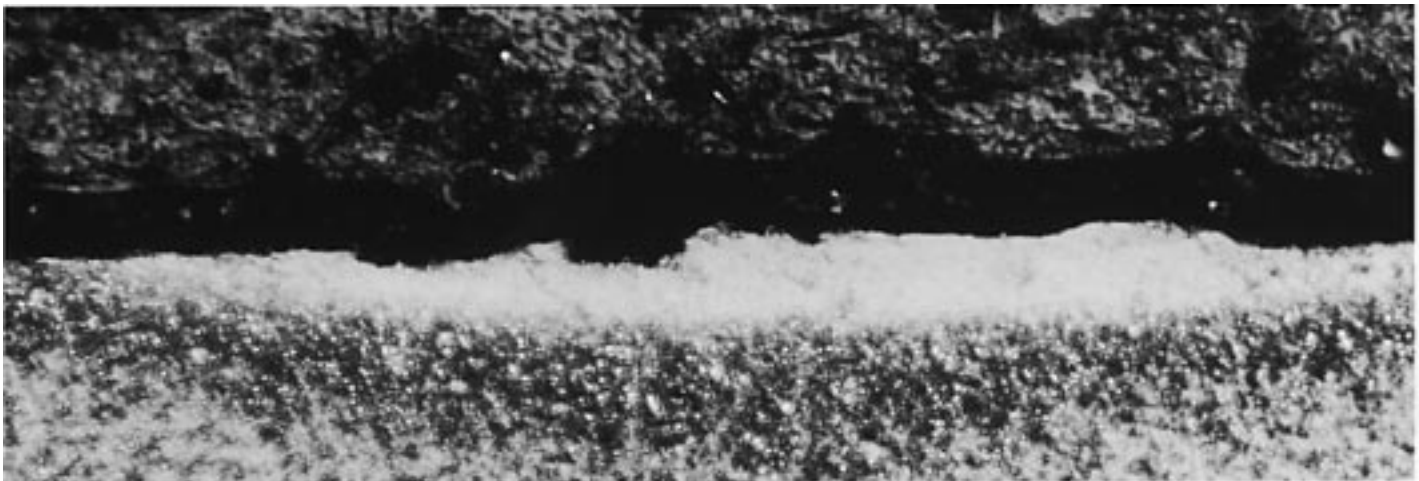
Figure 13

CROSS SECTION THROUGH A SCUFF MARK

This photomicrograph (at 250 magnification) shows the effect of a typical scuff mark on a bearing surface. Scuffing results when axial sliding motion is permitted between rings and rollers. Mishandling, prior to and during installation, is the chief cause. protective lubricant is usually absent or inadequate and the pressures and frictional heat, although instantaneous, are high enough to heat this area above the hardening temperature. The result is rehardening (the white areas) which yields a mixture of austenite and untempered brittle martensite.

The darker underlying zone is softened, tempered structure. None of these are desirable for sustaining load or shock. Thus they serve as nuclei for early failure of the bearing in service. Many early failures, often attributed to steel defects, have their origins in scuff marks.

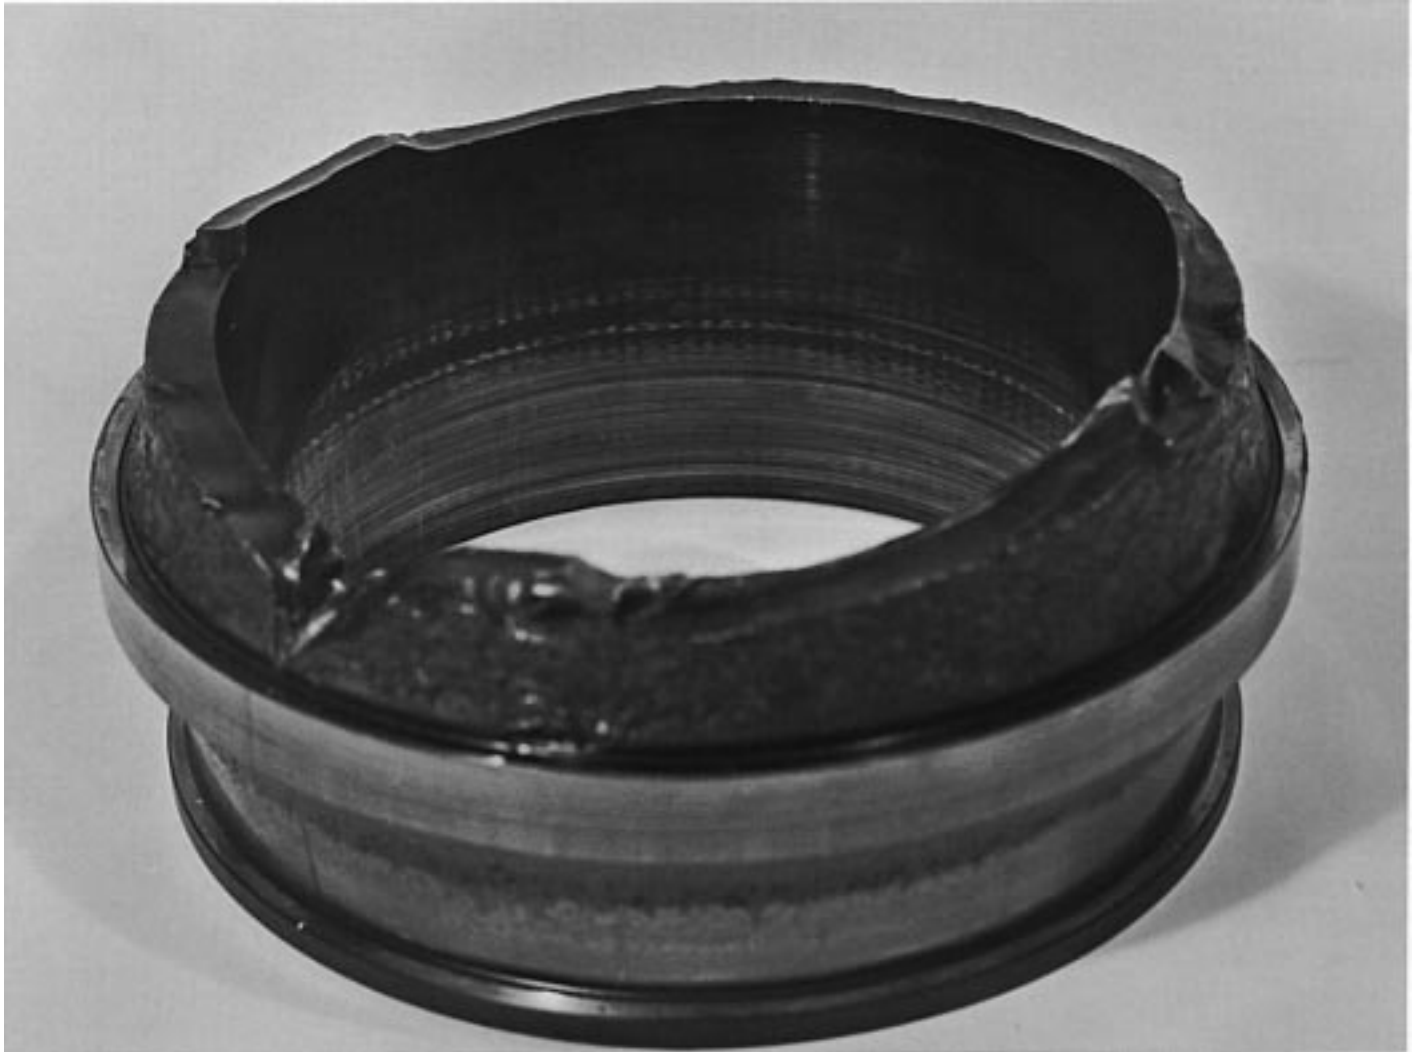
Figure 14

POOR SEATING ON TAPERED SHAFT

Serious damage can occur to a tapered bore bearing which is not seated properly on the shaft. An example of such damage is illustrated.

If the shaft taper is not correct, the inner ring will be improperly supported and failure can be expected.

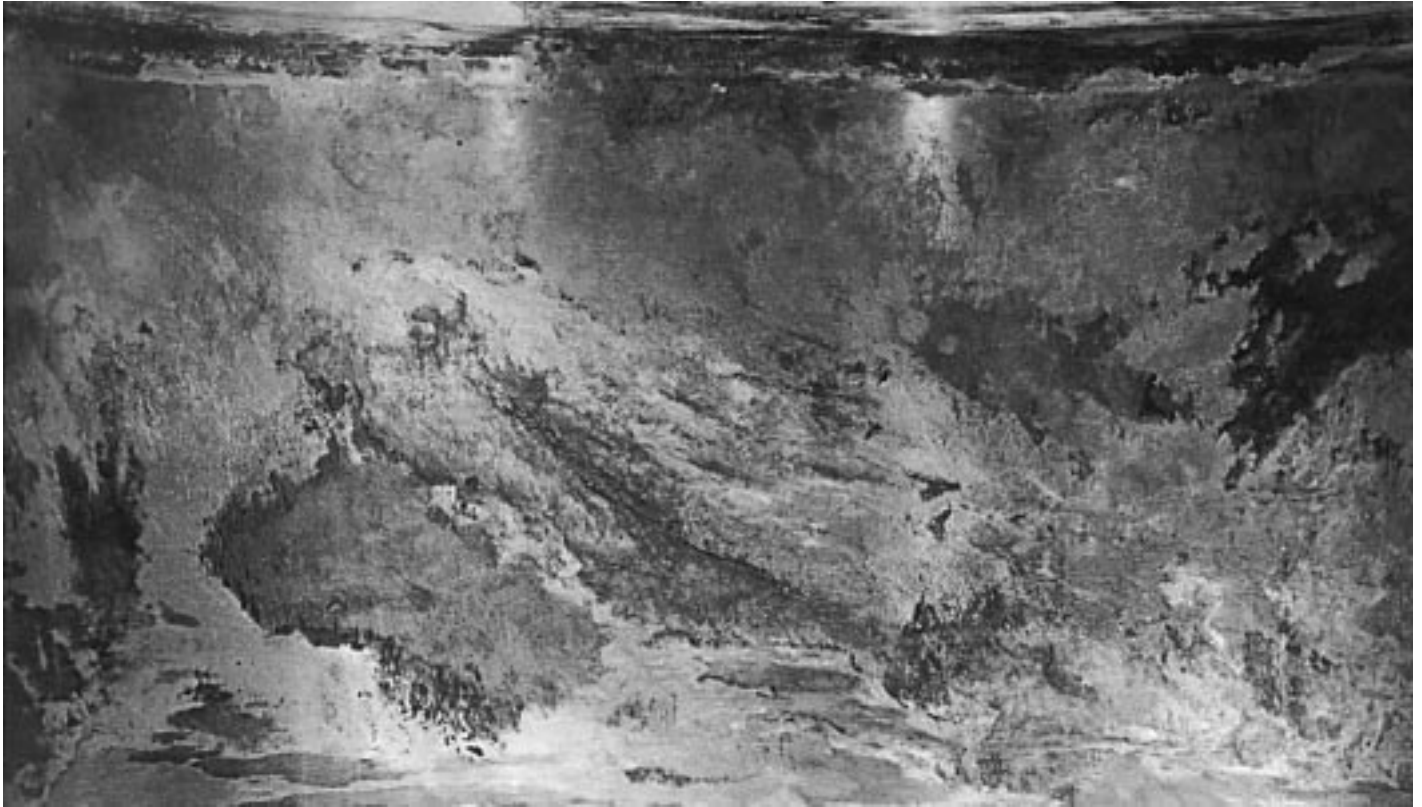
Figure 15

FRETTING CORROSION

Insufficient interference fit of an inner ring on a shaft will permit the ring to creep and result in fretting corrosion. The resulting oxides, being abrasive, accelerate wear of the shaft and the inner ring bore.

The lapping action of the abrasive also causes wear in the bearing itself and increases the internal clearance. This is an example of fretting corrosion in the bore of an inner ring. Outer ring O.D.'s can be similarly affected.

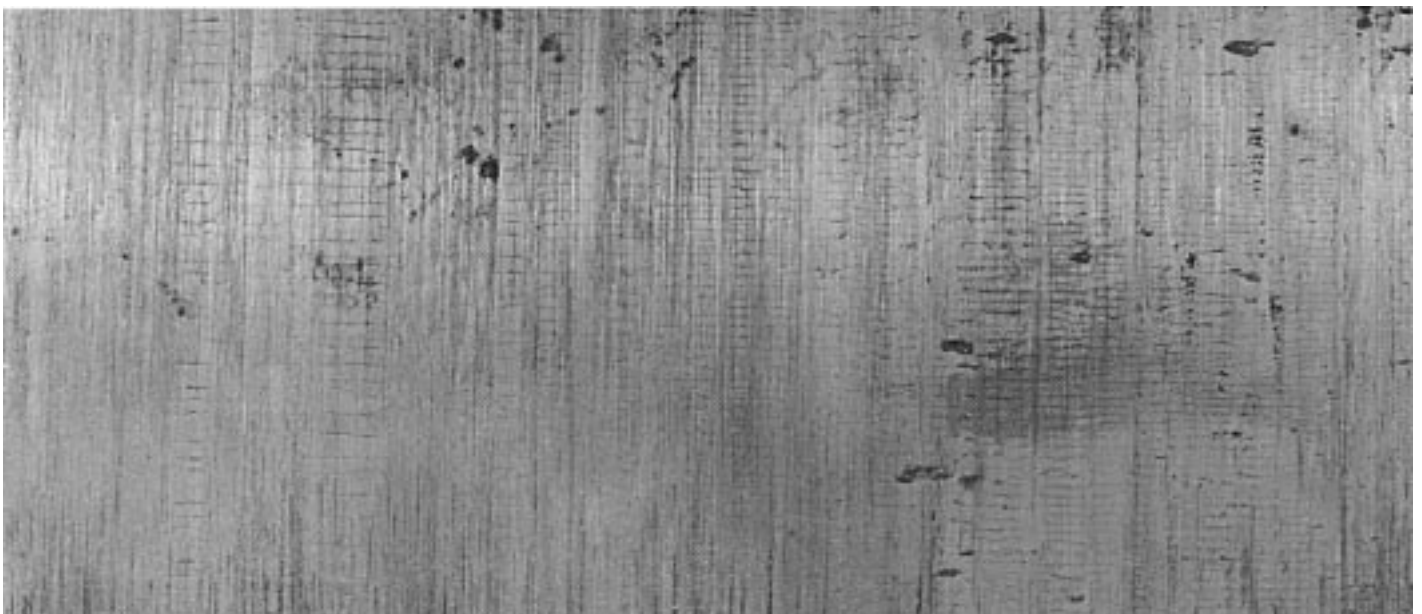
Figure 16

HEAT CHECKS

Heat checks occur on the boundary surfaces of a bearing as a result of relative motion between the bearing and a contacting part. This usually occurs when they are either loose-fitted or mounted with insufficient interference fit. When a bearing ring creeps, sufficient heat

may be generated to develop cracks on the rubbing surface. These cracks are normal to the direction of rotation. This photograph shows heat checks on the O.D. of an outer ring.

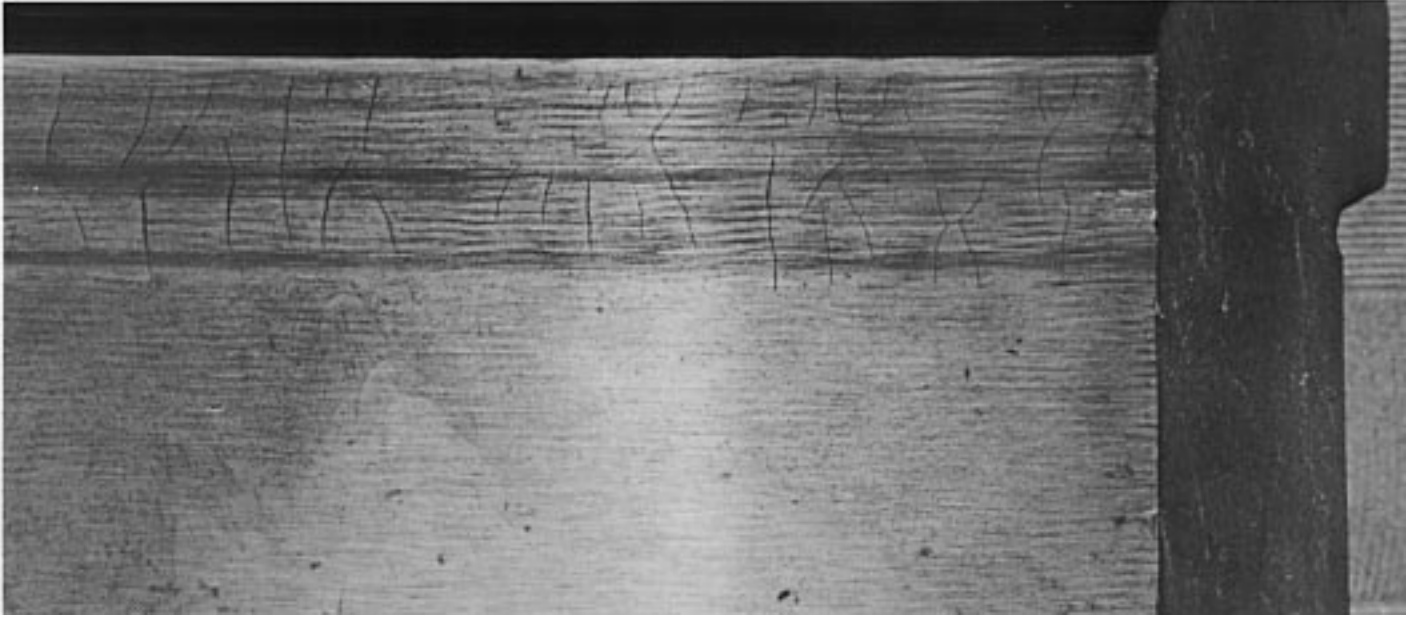
Figure 17 HEAT CHECKS

See description of Figure 16. These are heat checks on the bore of an inner ring. If the inner ring becomes heat checked, it should not be

subsequently mounted with an interference fit, since heat checks can cause the inner ring to fracture.

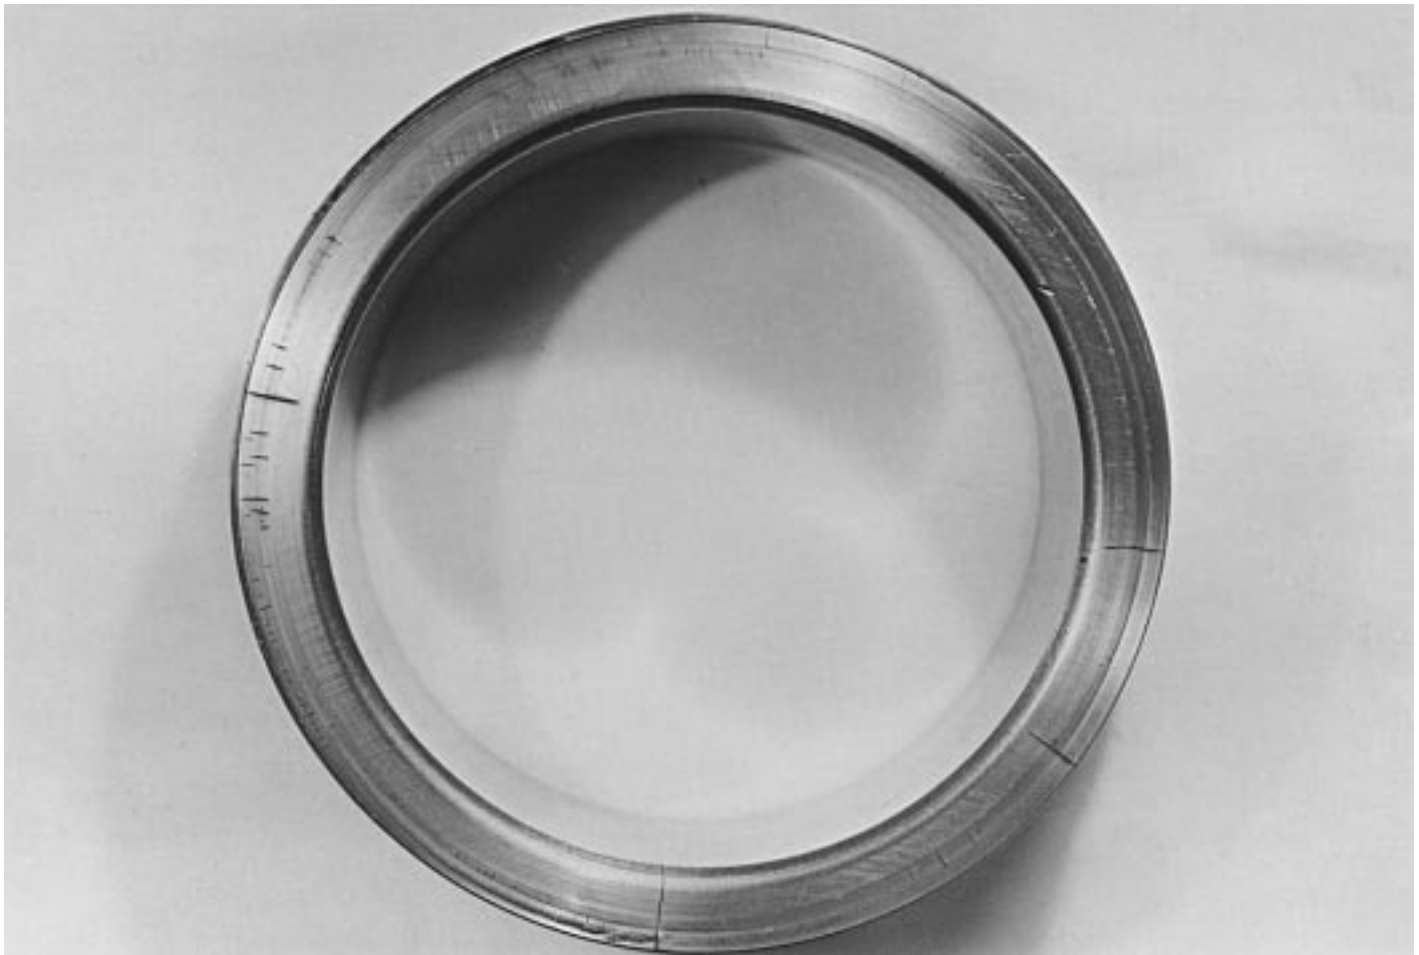
Figure 18 HEAT CHECKS

See Figure 16. This is an illustration of heat checks on the face of an inner.

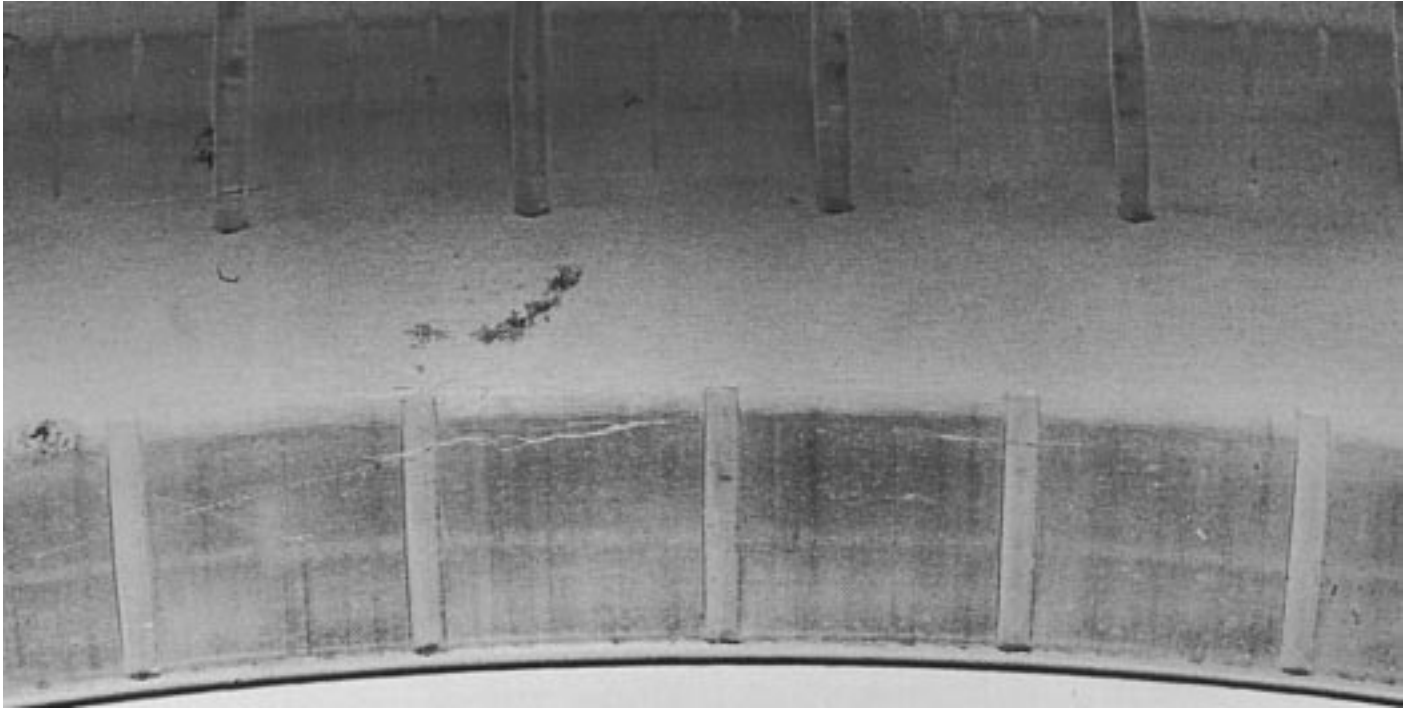
Figure 19

FALSE BRINELLING

While true brinelling is a flow of material due to excessive pressure that caused indentation in a part, false brinelling, on the other hand, involves an actual removal of material and is a wear condition.

The exact cause of false brinelling is not agreed upon by authori-

ties. It is known that relative motion, load and oxygen are prerequisites.
