TORRINGTON®

Roller Bearing Service Damage and Causes

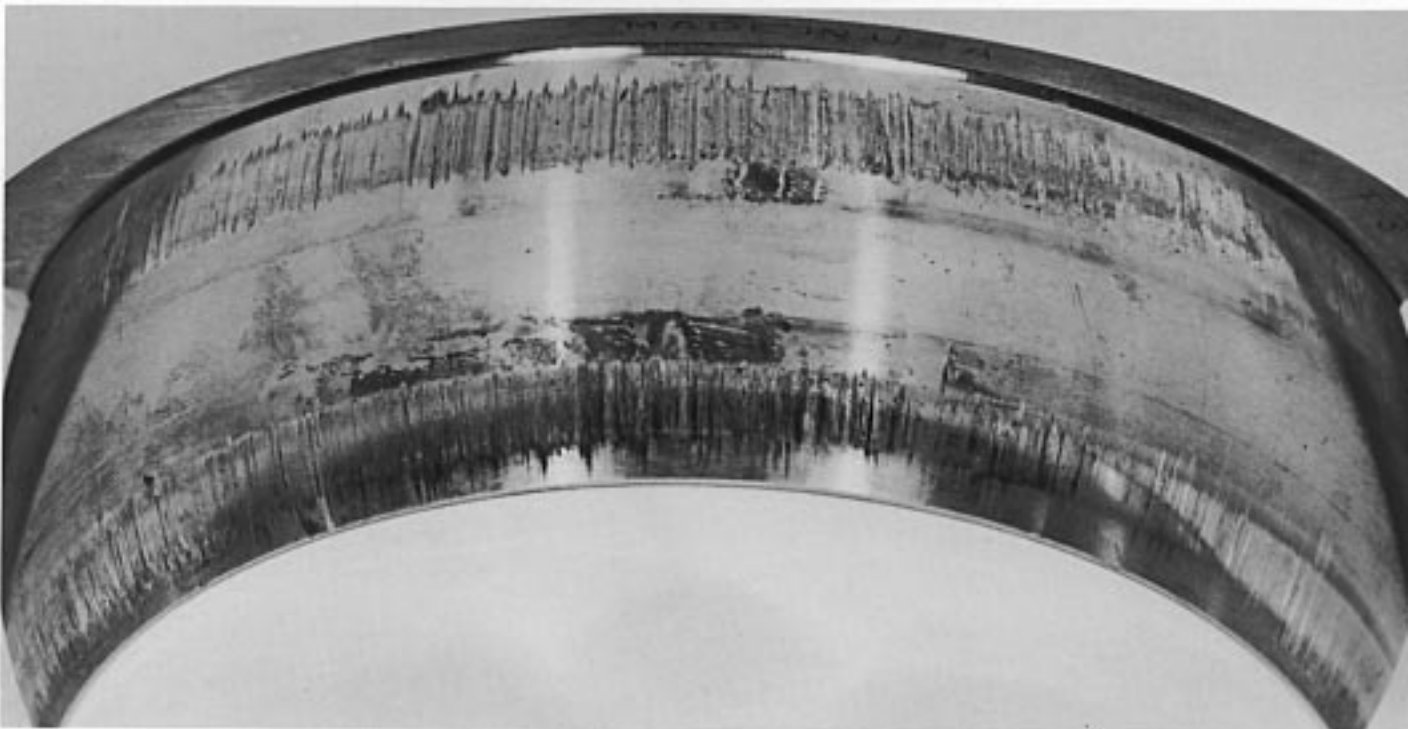
Figure 20

FALSE BRINELLING

This is another example of false brinelling resulting from rollers vibrating in the bearing raceways.

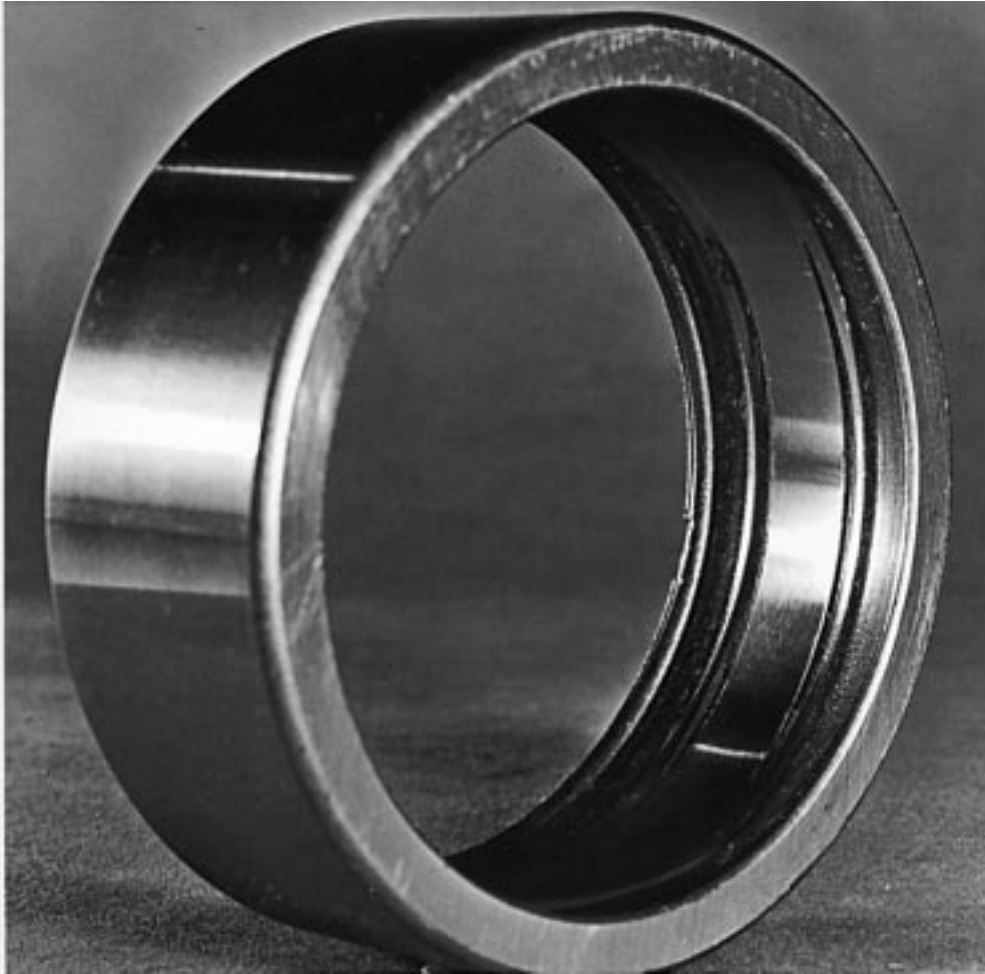
Figure 21
LUBRICATION FAILURE —
RACEWAY

Here is an example showing an advanced stage of failure in a spherical roller bearing outer ring resulting from inadequate lubrication. The roller paths are deeply grooved. The spall pattern is fine grained contrasted to that of normal fatigue. (See Figures 33 & 34.)

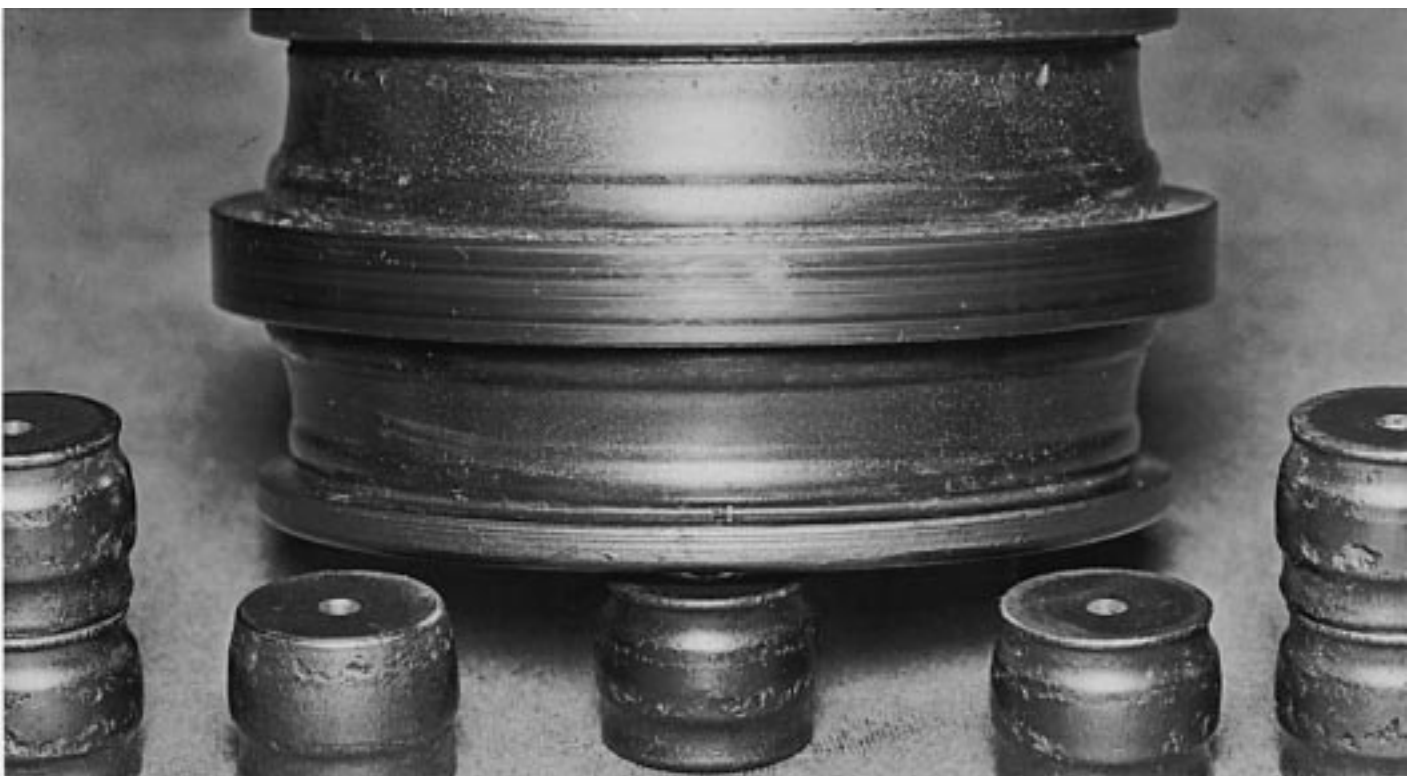
Figure 22
LUBRICATION FAILURE —
INNER AND OUTER ROLLERS

These are the companion parts for the outer of Figure 21. The roller paths are deeply grooved and the rollers severely worn to an inverted hour glass shape. Raceways and rollers usually have a dark brown discoloration in this type of failure.

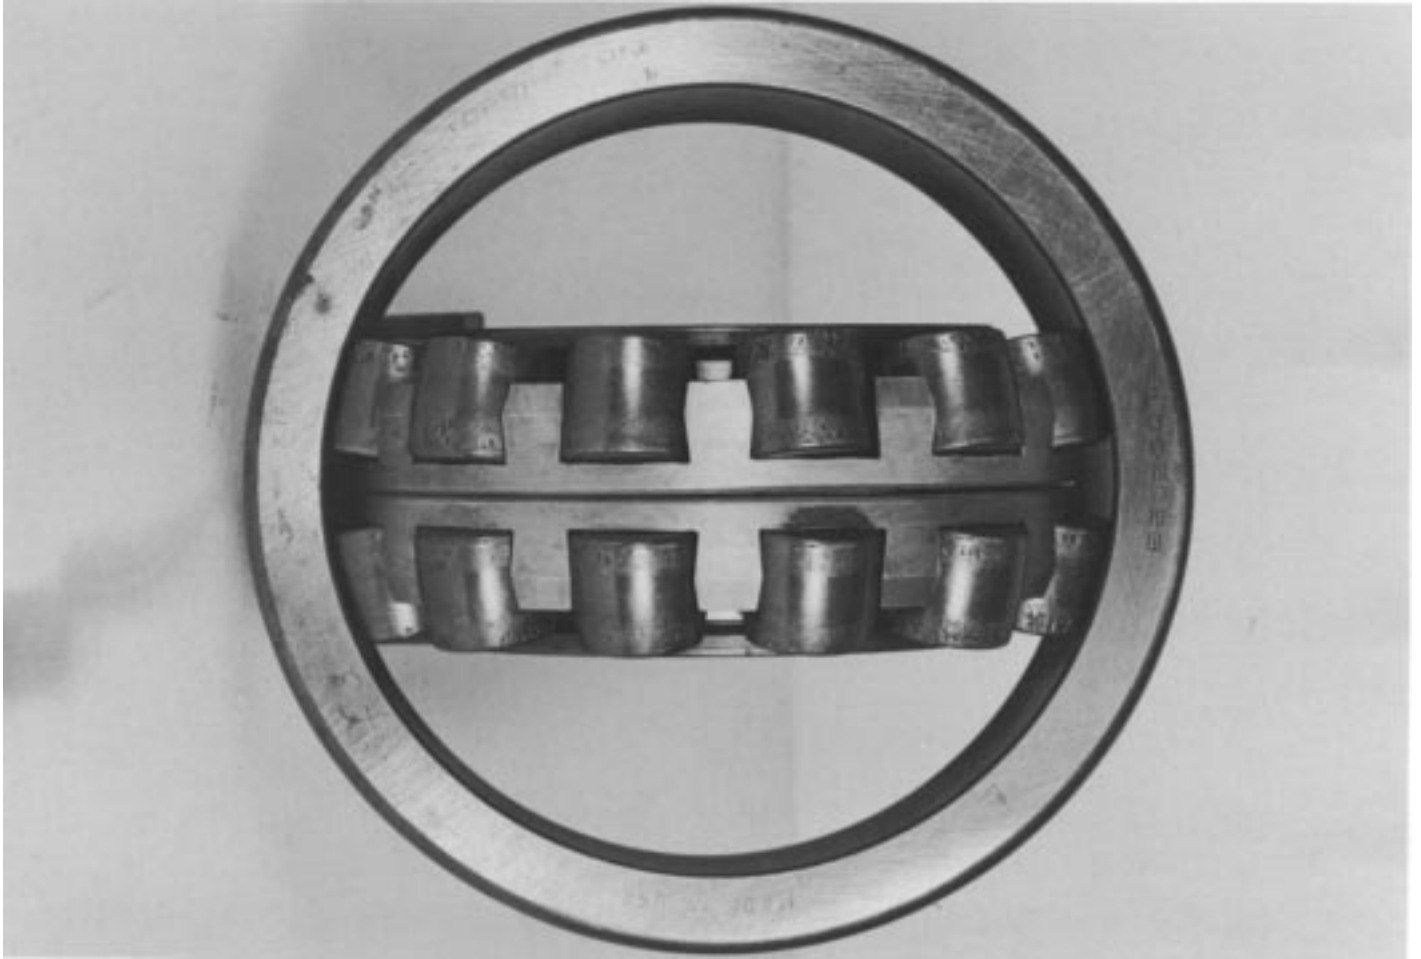
Figure 23

LUBRICATION FAILURE — ROLLERS

This is an example of a less advanced stage of spherical roller bearing failure due to inadequate lubrication. The rollers have started to spall on the ends in a comparatively fine grained pattern. Note that the ends of the rollers start to spall first while the centers are relatively intact.

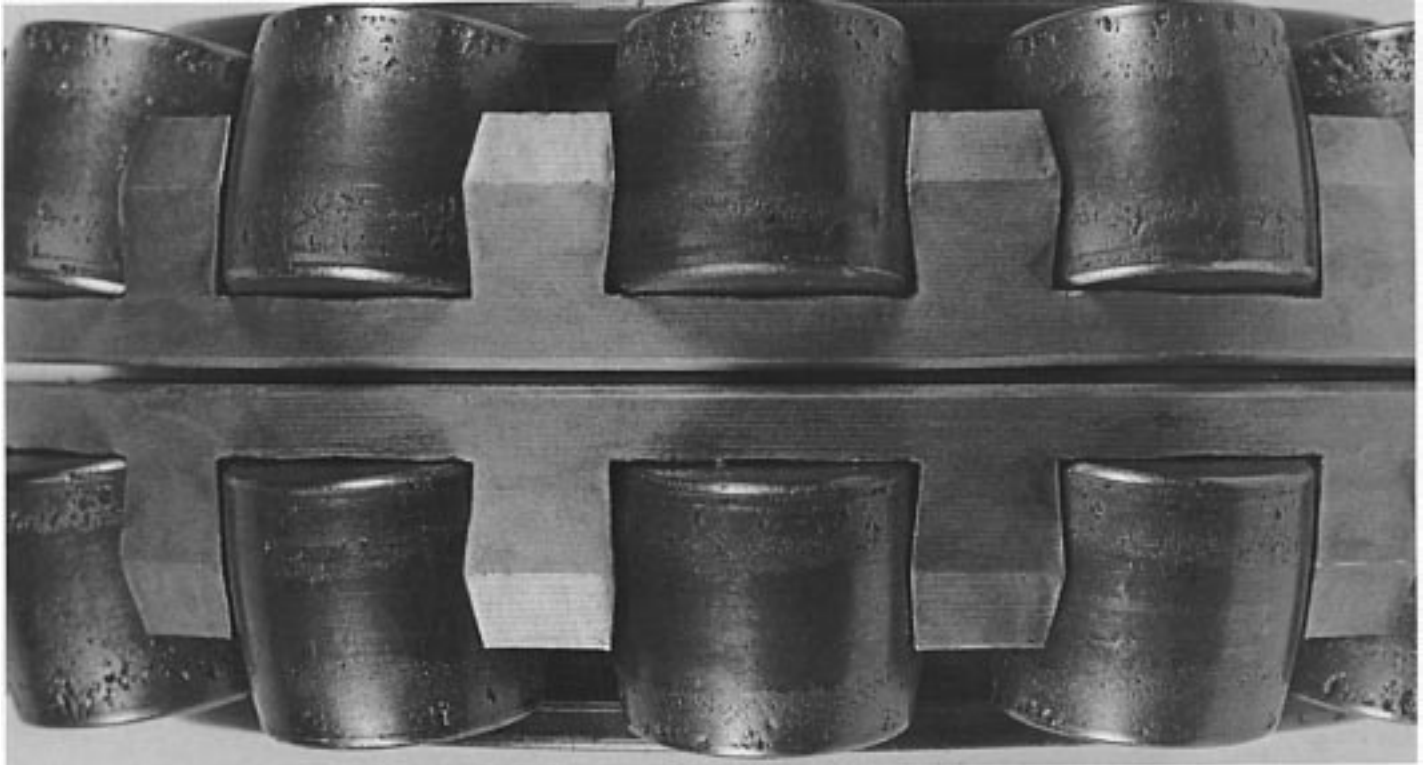
Figure 24

LUBRICATION FAILURE — ROLLERS

This is a close-up view of some of the rollers of Figure 23 and more clearly shows the spall pattern.

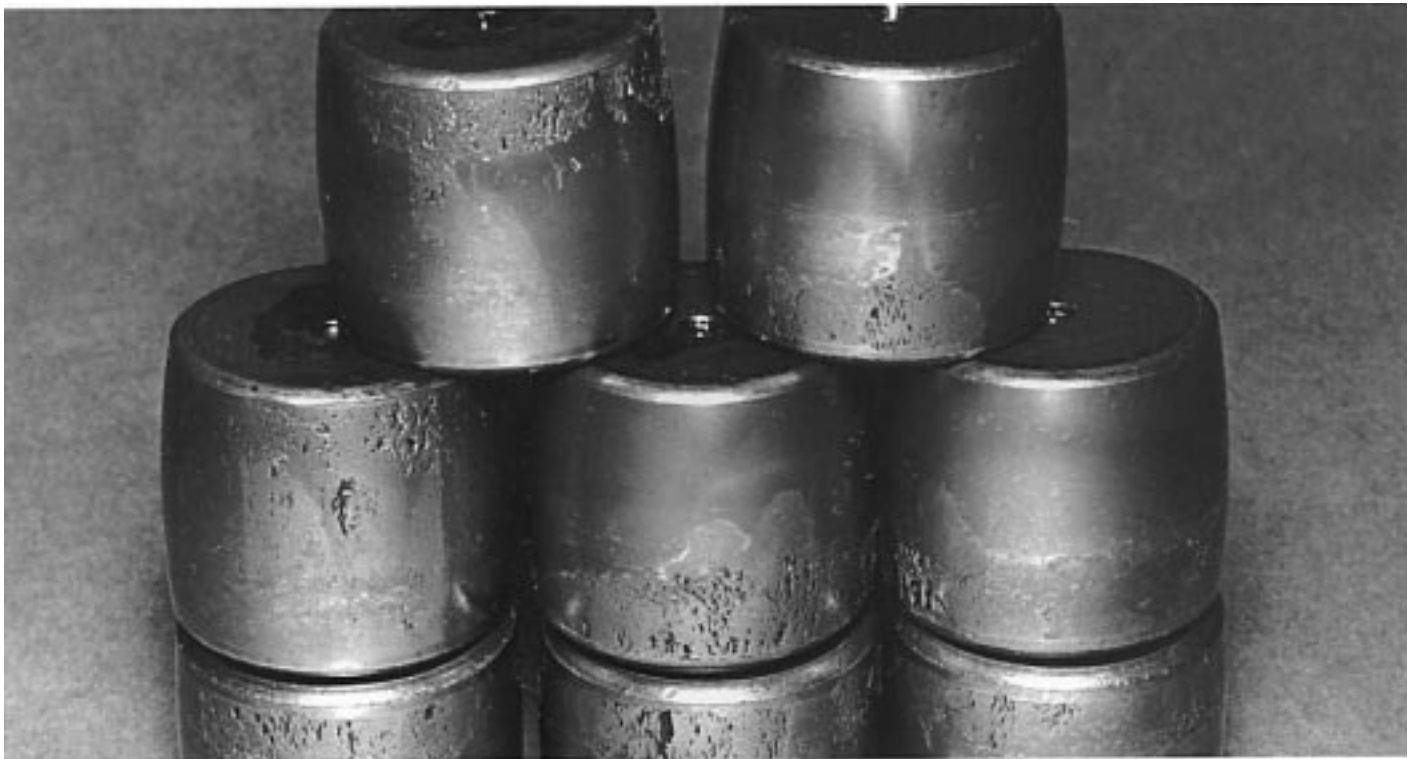
Figure 25

LUBRICATION FAILURE - ROLLERS

This is another example of roller damage due to inadequate lubrication.

Note the fine grained spall pattern. The failure feathers out from the large spalls to the original surface. In the lesser distressed areas, the surface has the pulpy appearance of a peeled apple.

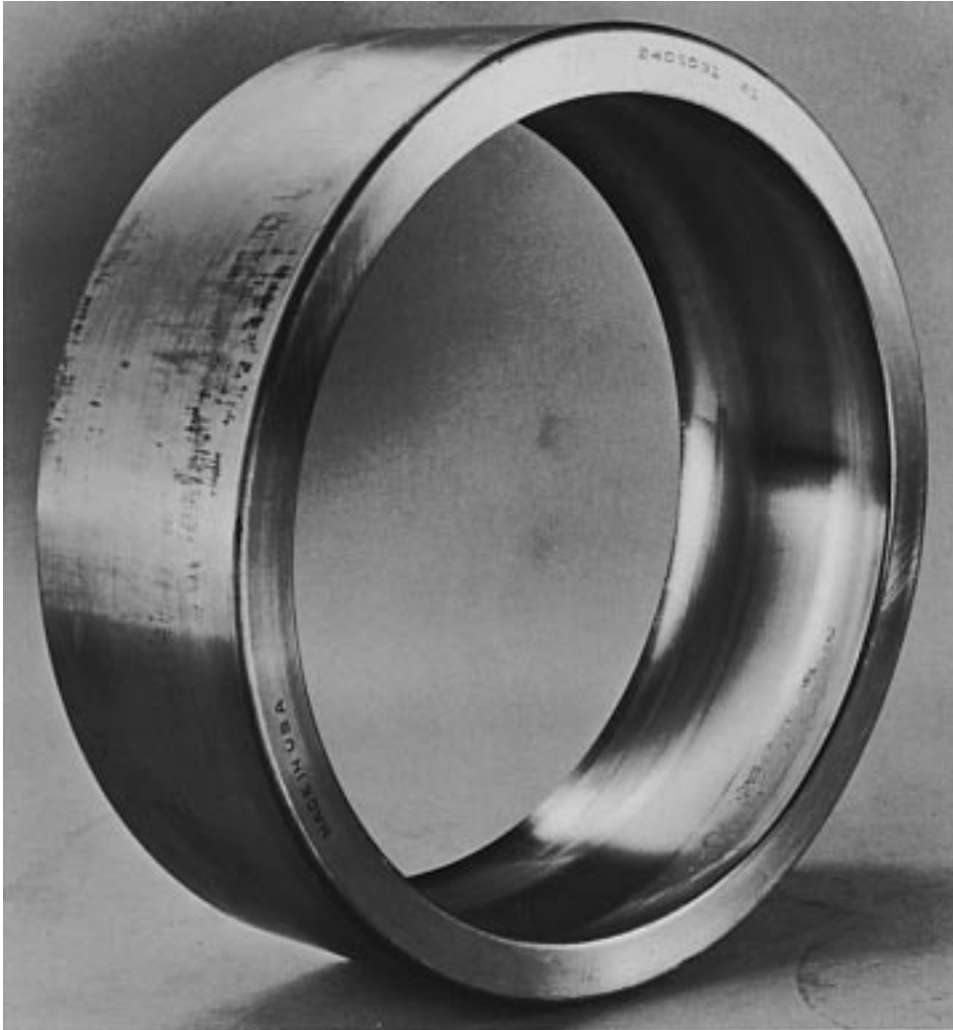
Figure 26
LUBRICATION FAILURE —
OUTER RING

This photograph shows an outer ring with a lubrication failure in an early stage. The failure is very shallow and has the appearance of a thin surface layer peeled from the raceway leaving a roughened area.

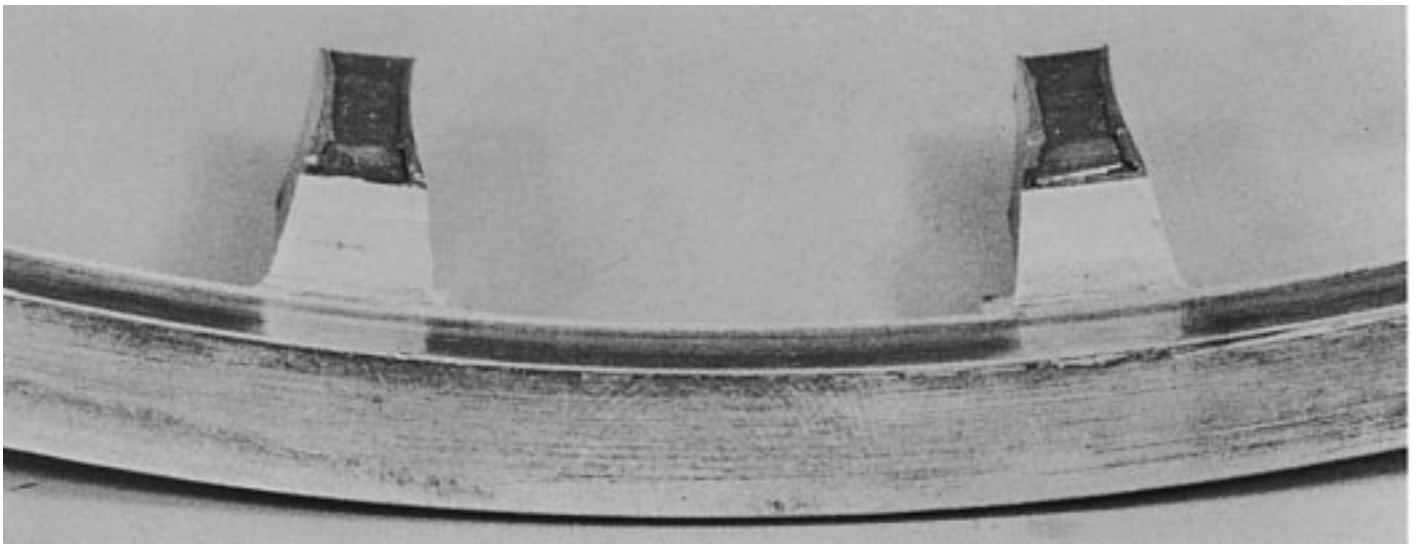
Figure 27
LUBRICATION FAILURE — RETAINER

Bronze retainers are sensitive to inadequate lubrication and can wear quite rapidly. In this case the web portion of the cage which rides on the center flange of the inner ring has worn to about half its thickness.

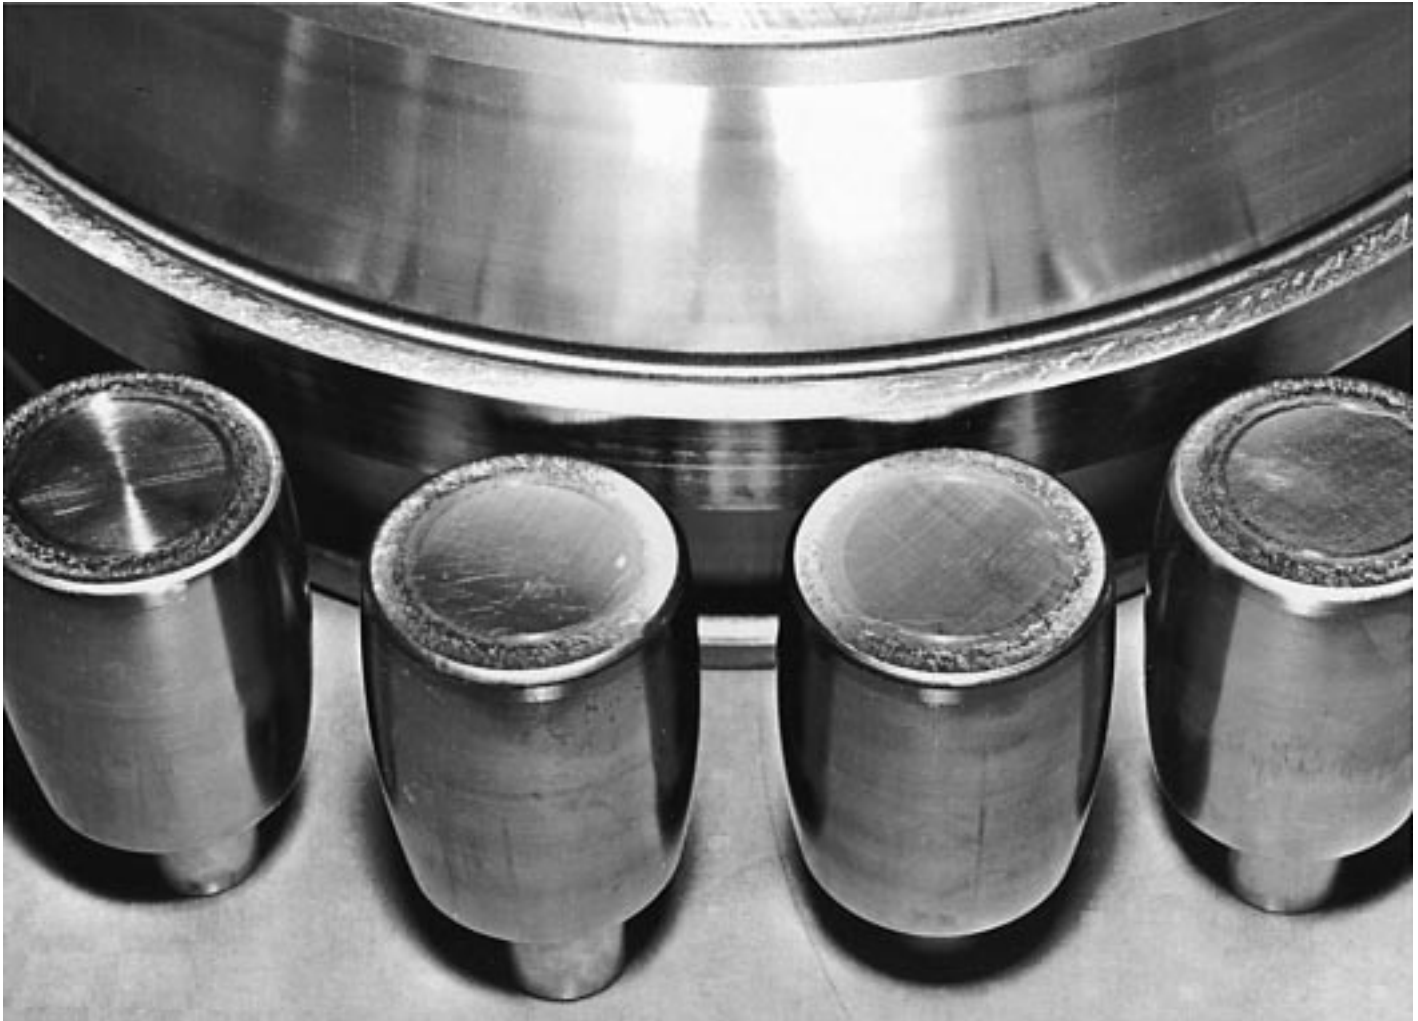
Figure 28

LUBRICATION FAILURE — THRUST CONTACT SURFACES

The cycloidal smear marks on the thrust flange and roller ends are due to the breaking of the oil film at this point.

This is the result of inadequate lubrication and/or overload.

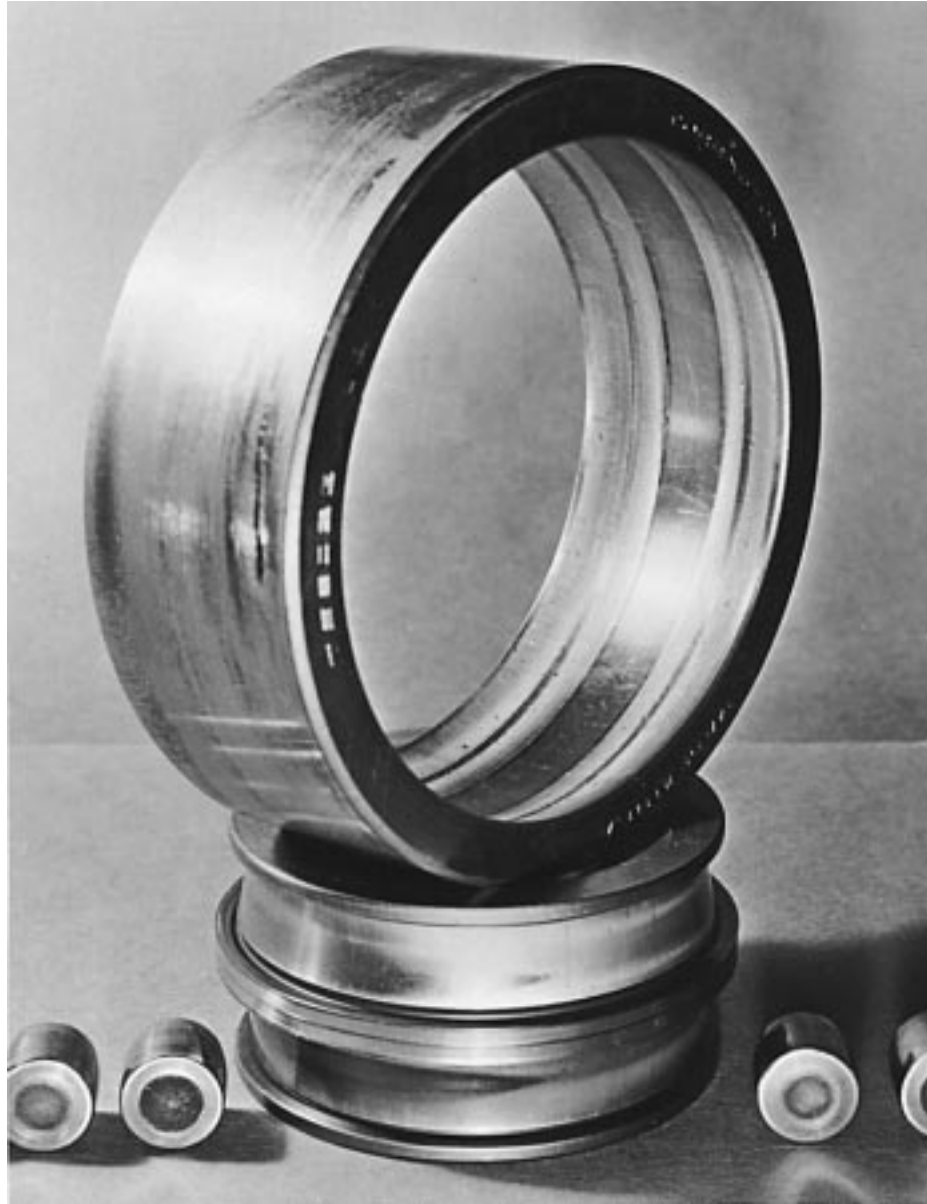
Figure 29
ABRASIVE WEAR — RINGS AND ROLLERS

Abrasive wear can be identified by the frosty gray or lapped appearance of the affected surfaces.

Actual wear is usually most obvious on the O.D. of the inner ring center flange and on the thrust contact surfaces of the rollers. Wear on both of these areas can be seen in this illustration.

The roller path pattern in the outer raceway is interesting. Each path has the characteristic frosty lapped appearance. The narrow dark band in each path is the original surface of the raceway. The

retainers of the bearing became charged with the abrasive contaminant which in turn caused the rollers to wear at their largest diameter. The rollers did not contact the outer ring at these zones, leaving the band of original surface. Continued operation would of course wear away these zones also.

The same phenomenon occurs on the inner raceways also but usually is not as pronounced as on the outer raceways.

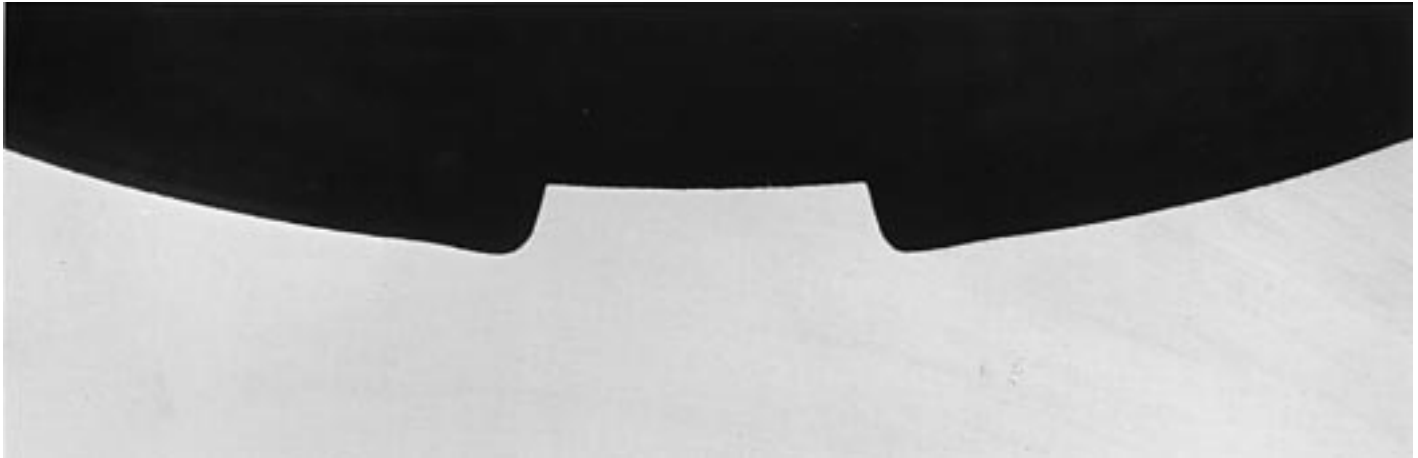
Figure 30

ABRASIVE WEAR — OUTER RING CROSS-SECTION

This photograph shows a cross-section of the outer ring of a self-

aligning spherical surface, but the abrasives have worn the paths down to the shape shown, which is that of the roller contour.

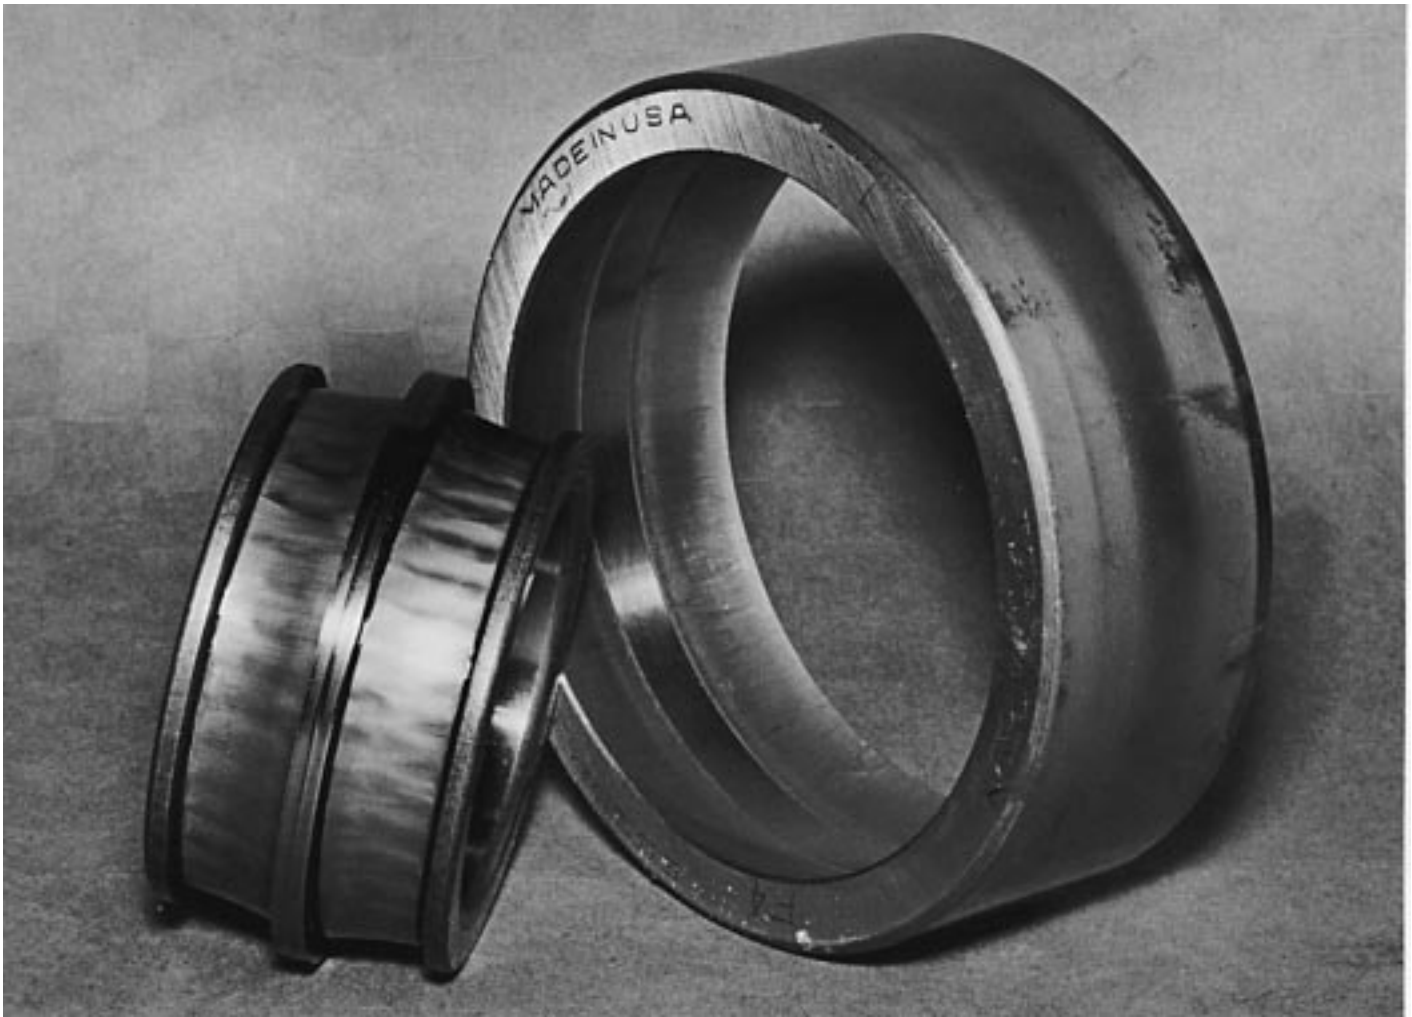
Figure 31

ABRASIVE WEAR — INNER AND OUTER RING

The bearing pictured had been in service in a shaker screen. Wear was due to abrasive contamination. The wavy pattern of the inner

raceways resulted from vibration and is not uncommon in screen applications.

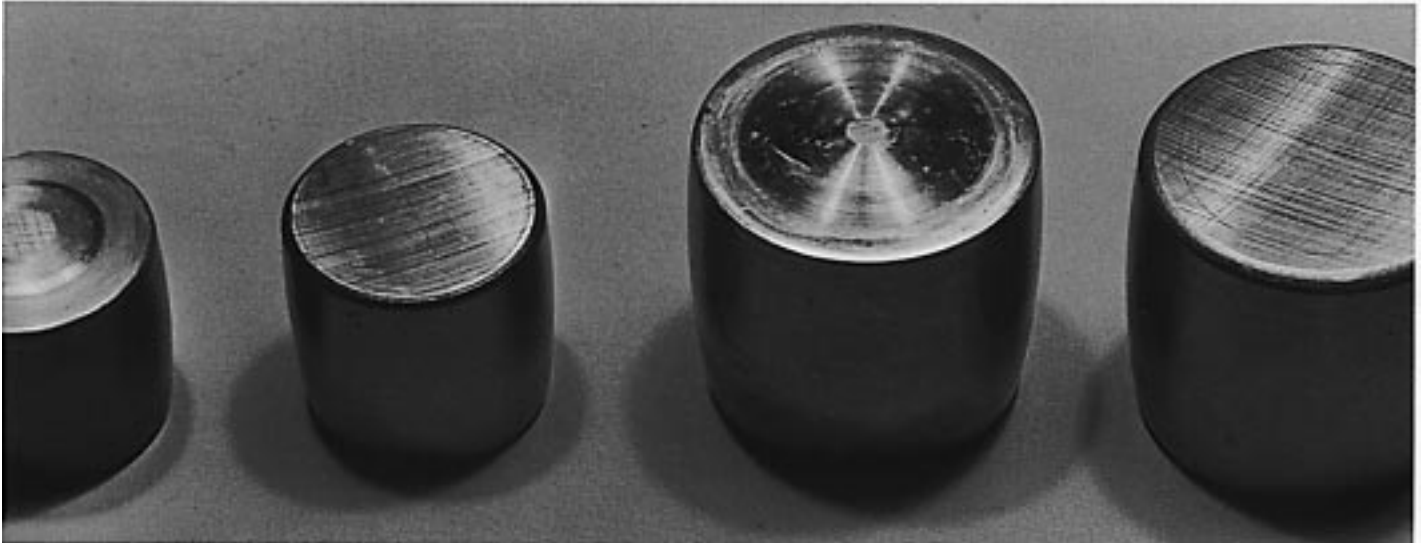
Figure 32

ABRASIVE WEAR — ROLLER END

This photograph shows the pattern on roller ends where abrasive wear had occurred. Two sizes of rollers are shown. Roller ends are worn to the contour of the retainer pocket bottom.

For comparison, two new rollers are also pictured.

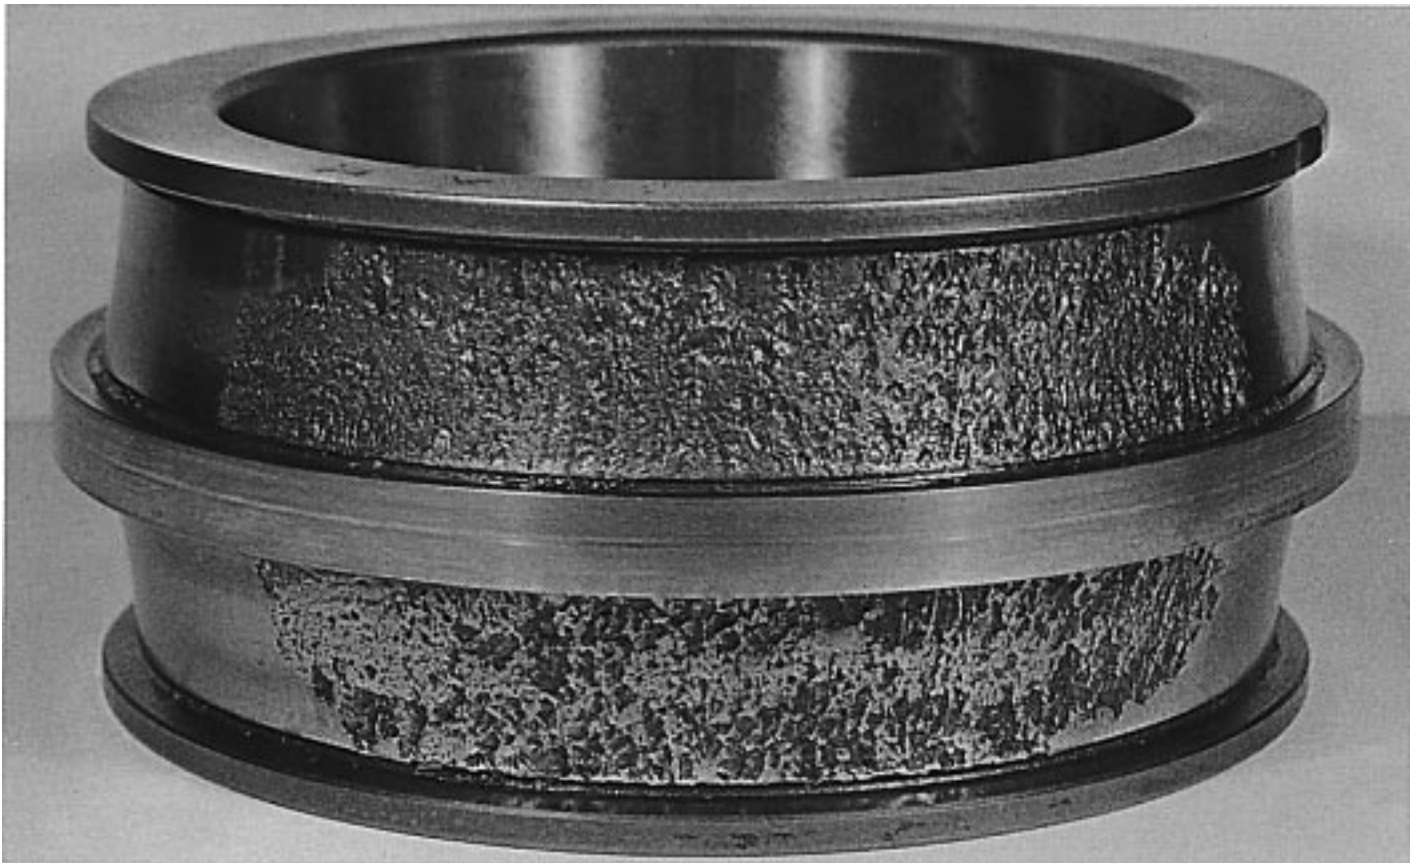
Figure 33

FATIGUE

The normal failure of a bearing is fatigue. Pictured is a typical failure on an inner ring. The coarse grained pattern should be noted in contrast to the pattern of a lubrication or abrasion failure. Good

loading conditions are evident, the load zone arcs on both roller paths being of equal length.

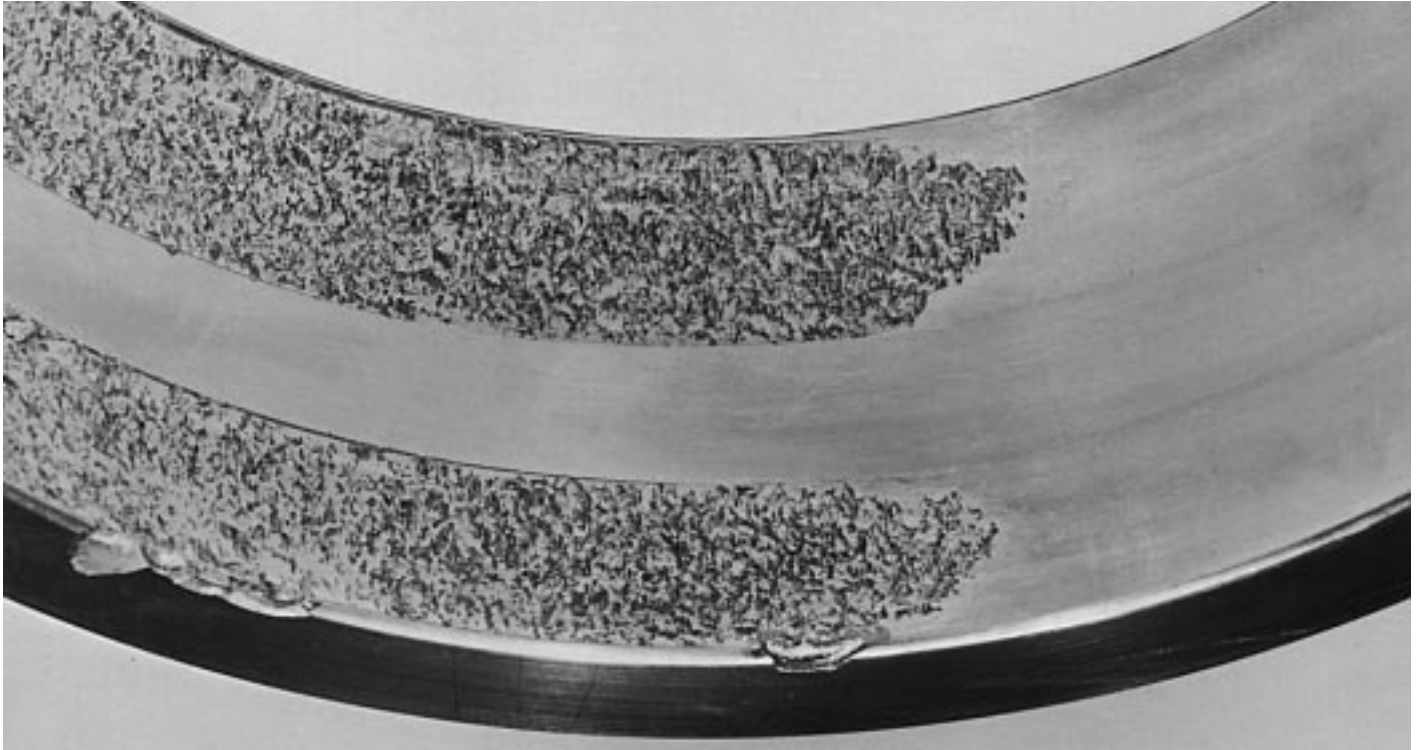
Figure 34

FATIGUE

Note comments on Figure 33. This is a typical fatigue of an outer ring. Again, loading options were good.

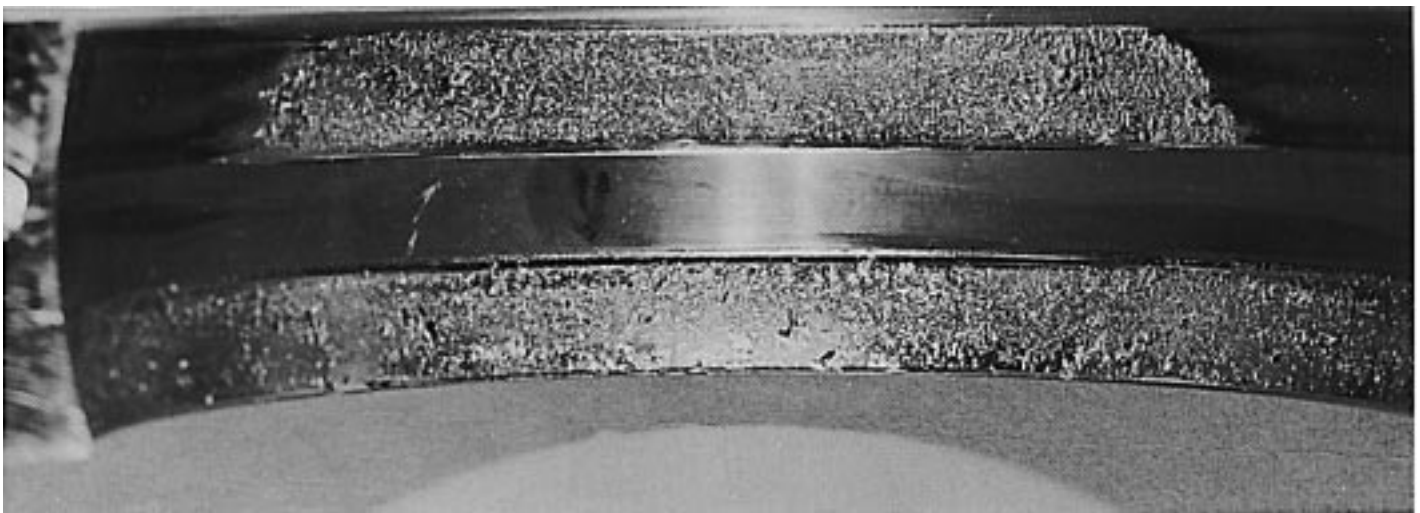
Figure 35

THRUST LOADING

This photograph shows the load pattern of an outer ring loaded in thrust. The spalling on one of the paths covers a much longer arc than on the other. In addition, there is an axial displacement of roller paths in the direction of the thrust load.

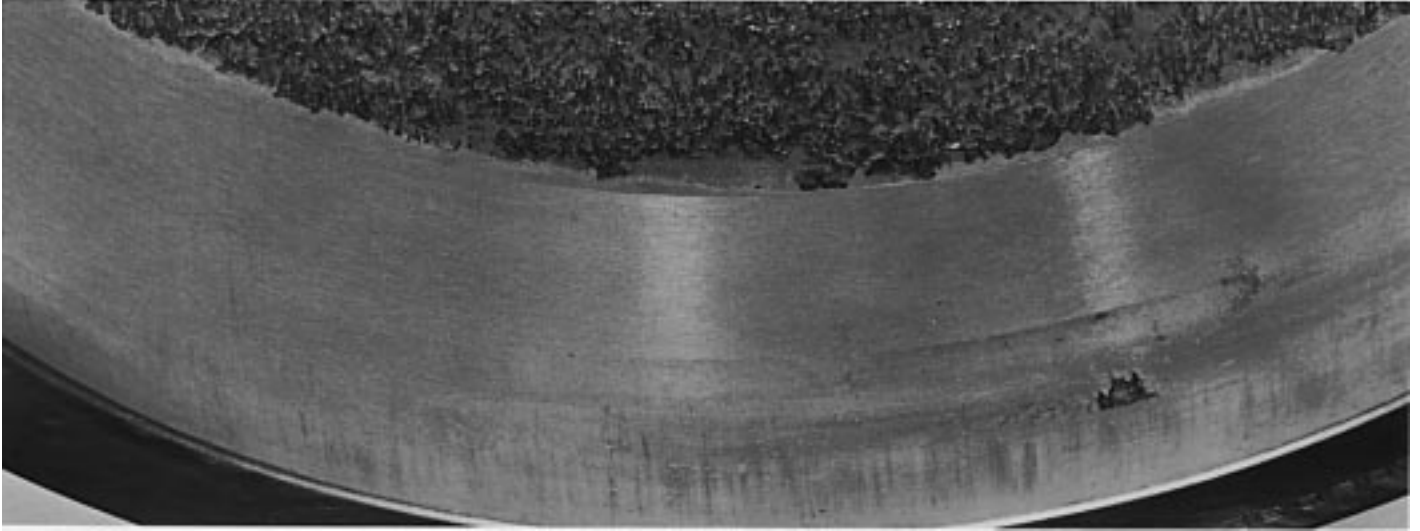
Figure 36

THRUST LOADING

This illustration is the same type of failure, thrust loading, as that of Figure 35. However, the thrust loading was more severe and the roller

path has been displaced to the extent that it has run to the edge of the outer and fractured pieces from the edge. Failure in both cases resulted from fatigue.

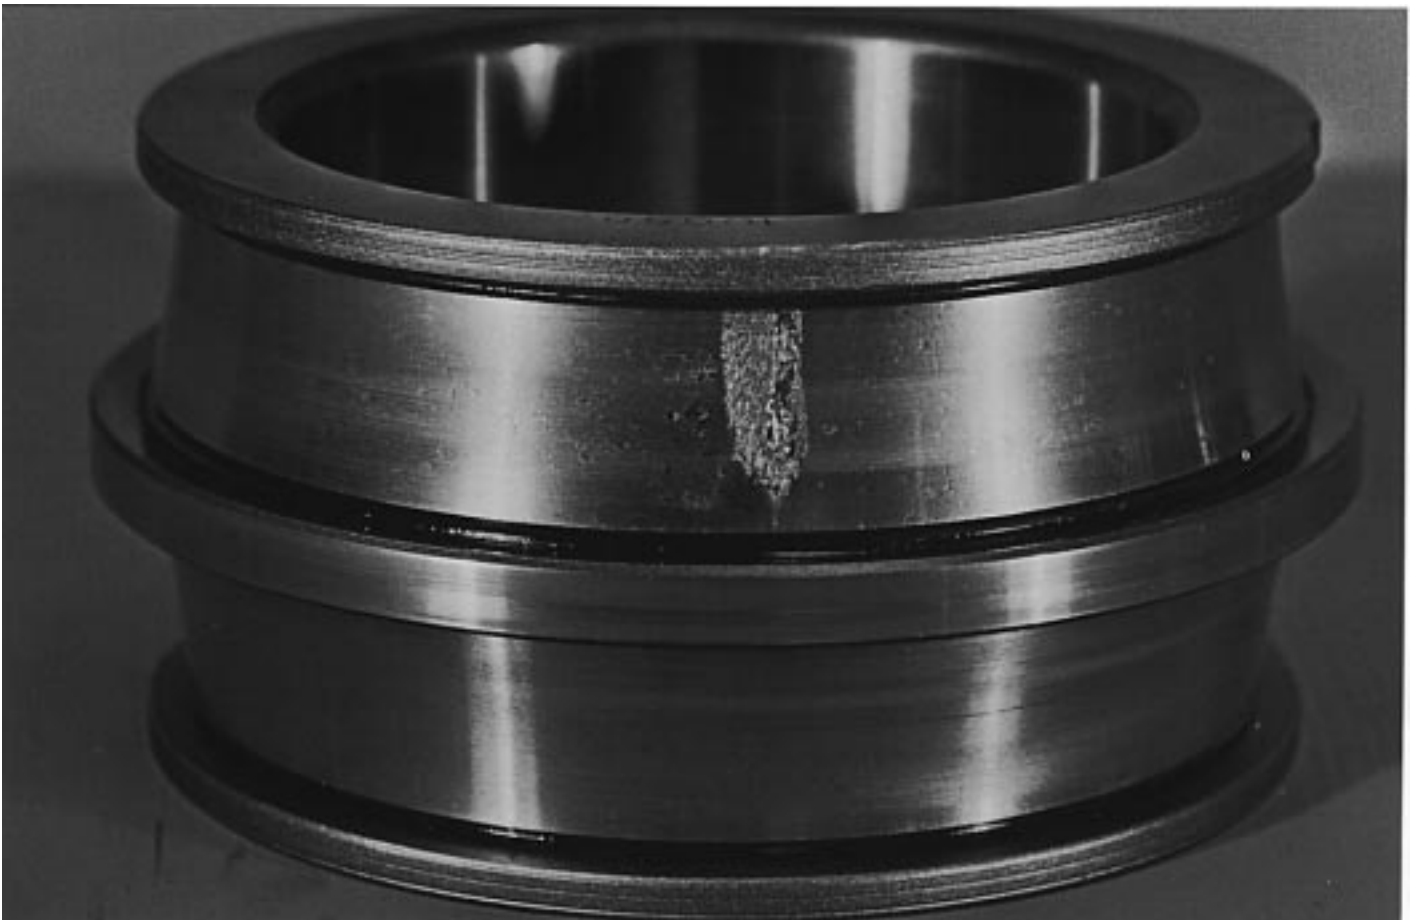
Figure 37

SINGLE SPALL

The single spall on this inner ring was caused by mechanical damage to the bearing, either in handling or in operation; the material, being overstressed at this point, failed prematurely.
